# **Analysis of the Safety Monitoring of Earth Dams at the Belo Monte Hydroelectric Plant: Case Study of Dikes in the Filling and Operation Scenario**

MODESTO, R. R.<sup>1</sup>; ALENCAR JÚNIOR, J. A.<sup>2</sup>; LIMA NETO, A.<sup>3</sup>.

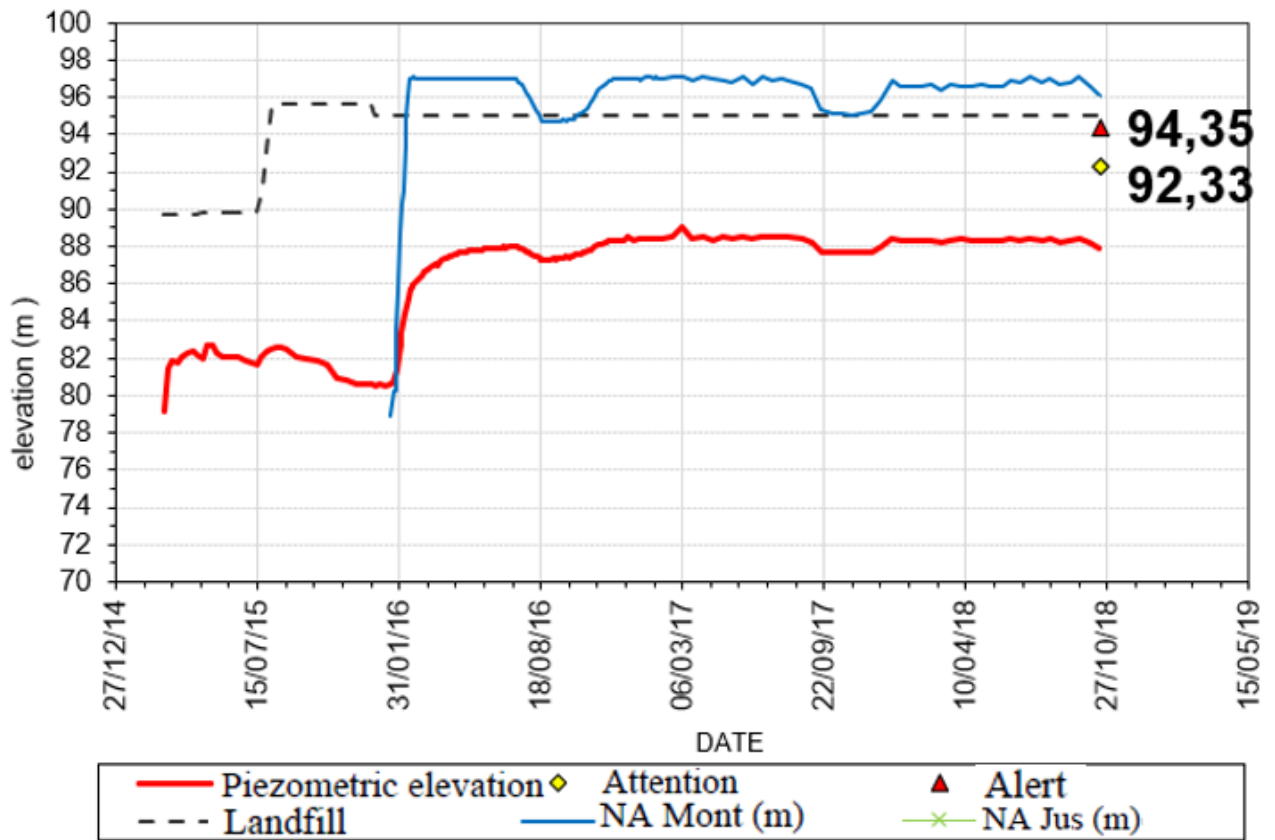
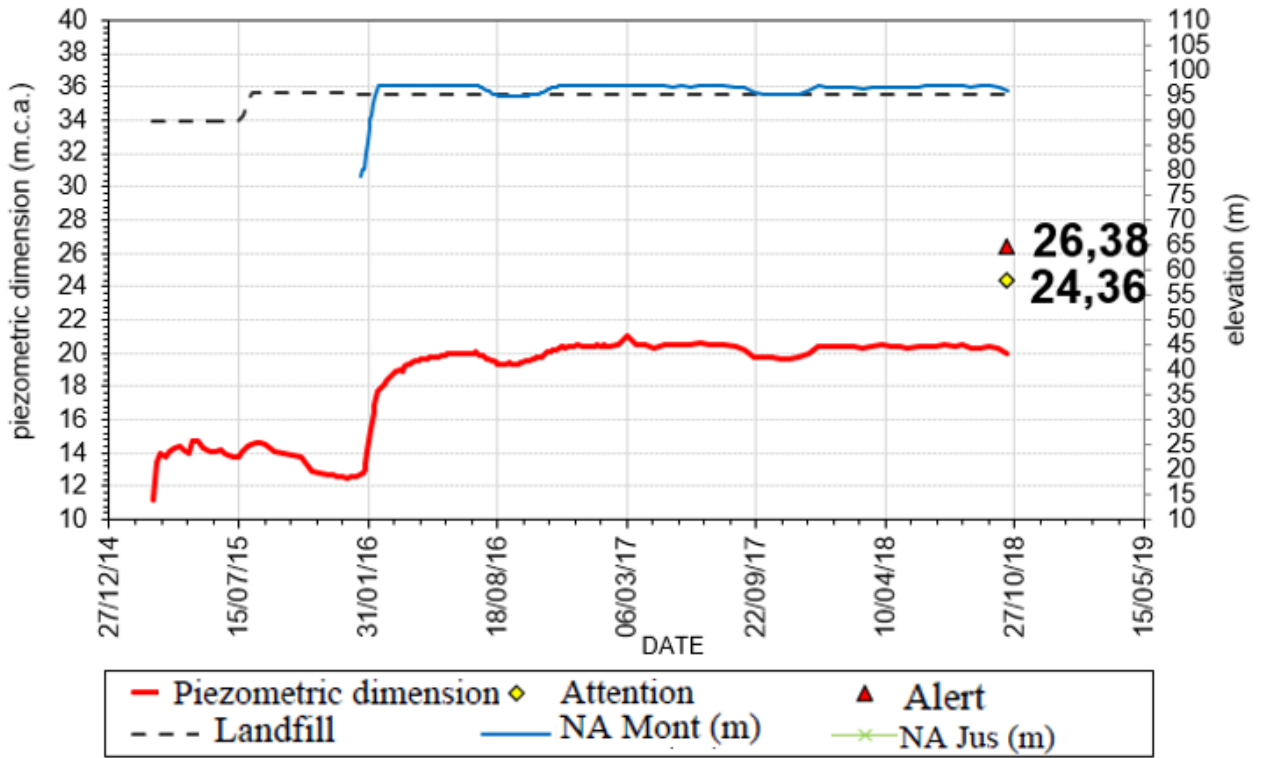
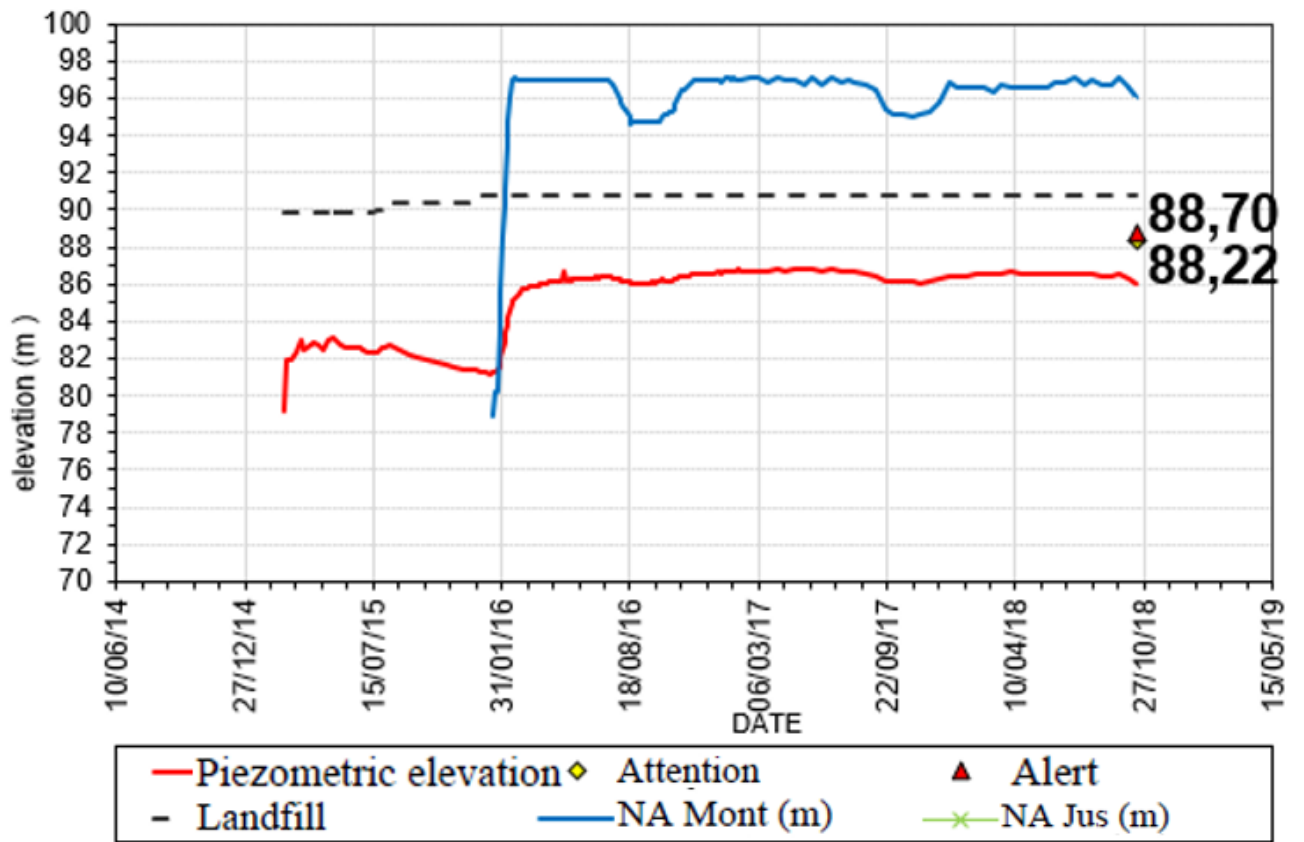
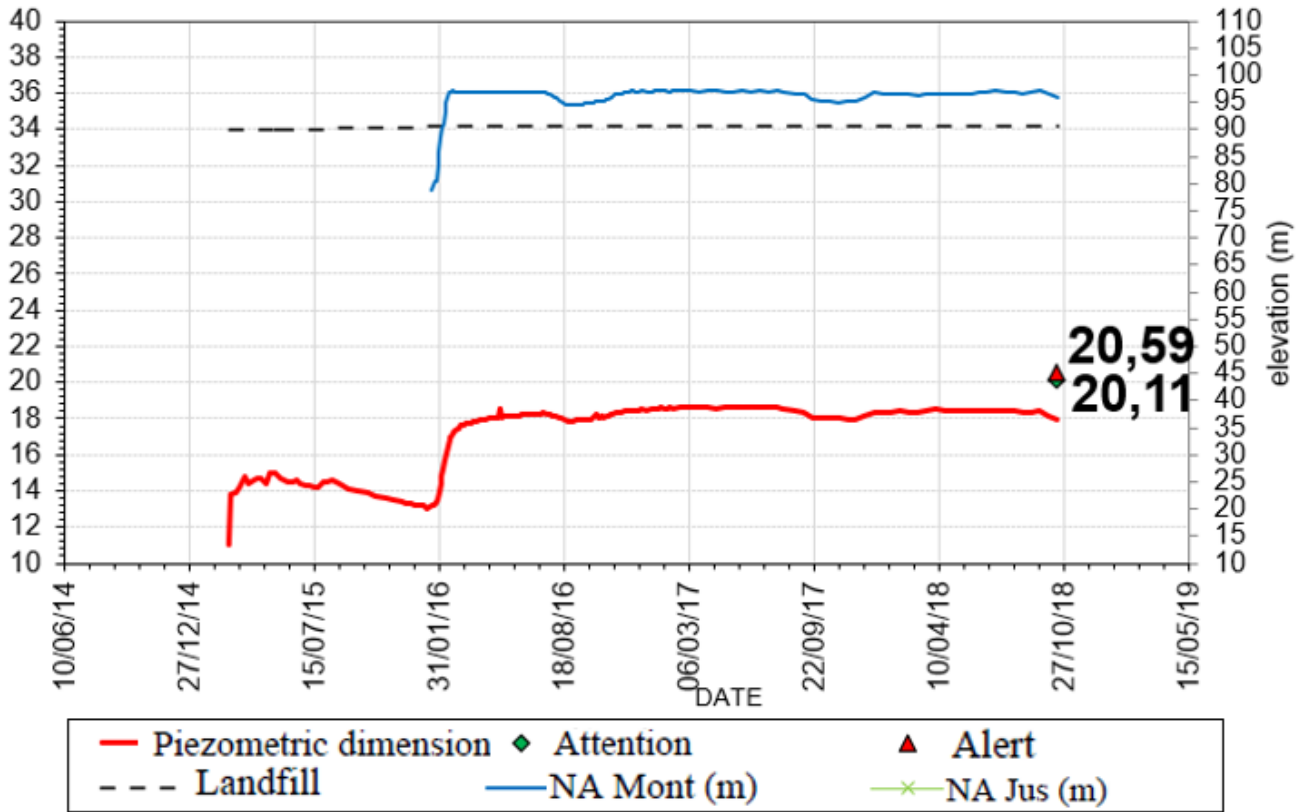
The behavior of the data of the piezometers located in the body of the dikes 01-A, 01-B and 01-C between the period of filling and operation were presented without great variations. However, on dike 01-A, piezometers 02 and 04 were the instruments that came closest to the values of attention and alert, both concurrently in the same period between the months of March to May 2017. The PZ-D01A-02, has values of attention to a quota of 92.33m and alert of 94.35m and the values of the attention and alert load are respectively 24.36 mca and 26.38 mca. The reading on March 6, 2017 recorded a quota of 89.01 and a load of 21.04, the closest to the attention values. The PZ-D01A-04, on the other hand, has attention values for a quota of 88.22 m and an alert of 88.70 m and the values for the attention and alert load are respectively 20.11 m.c.a and 20.59 m.c.a. The reading recorded on May 29, 2017 recorded a quota of 86.79 and load of 18.68, that is, values very similar to those established as a warning, as shown in Figures 9, 10, 11 and 12.

**Figure 9** – Reading the piezometric dimension (m) of the piezometer (PZ-D01A-02) of the dike 01-A

**Figure 10** - Piezometer load reading (m.c.a) of the piezometer (PZ-D01A-02) of dike 01-A

**Figure 11** - Reading the piezometric dimension (m) of the piezometer (PZ-D01A-04) of the dike 01-A

**Figure 12** - Read the piezometric load (m.c.a) of the piezometer (PZ-D01A-04) of the dike 01-A

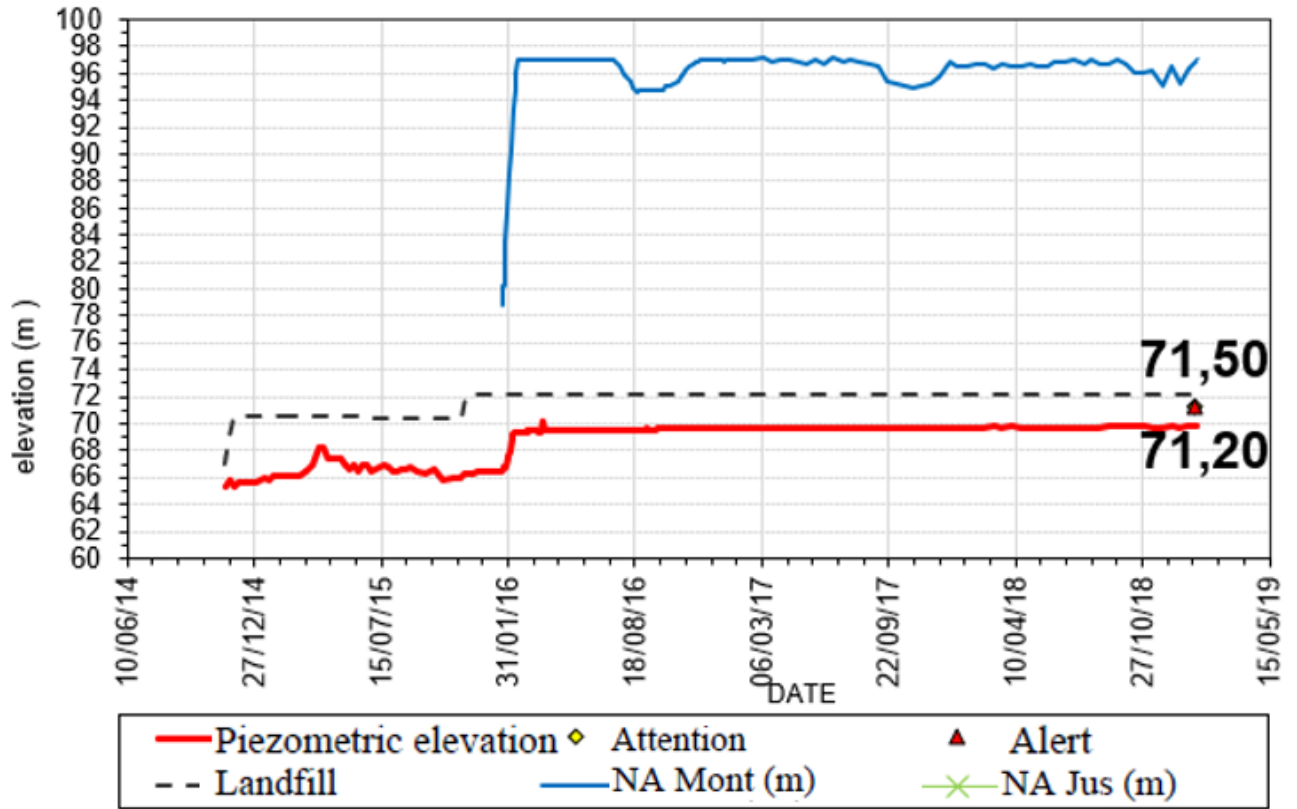
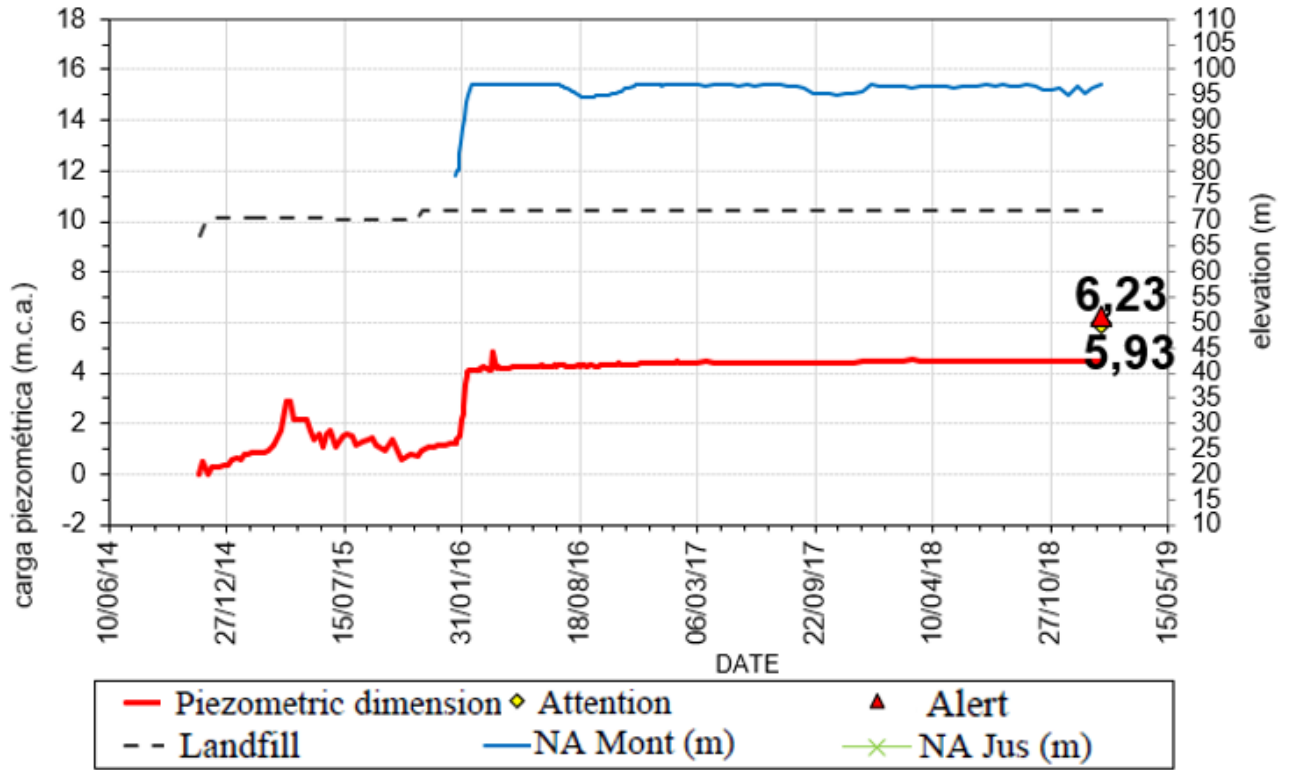
present data to verify the safety of the structure. The PZ-D01C-06 is the only one that presents its data close to the values of attention and alert. However, despite being readings very close to the levels of attention and alert, graph 34 shows stabilization of the values of quota and load obtained. Between the period studied, the reading on March 6, 2018 has values of 69.82 for quota and 4.55 for cargo, and its reference values are 71.20 for quota and 5.93 for cargo, as shown in the Figures 13 and 14.

**Figura 13** - Reading the piezometric dimension (m) of the piezometer (PZ-D01C-06) of the dike 01-C

**Figure 14** - Read the piezometric load (m.c.a) of the piezometer (PZ-D01C-06) of the dike 01-C

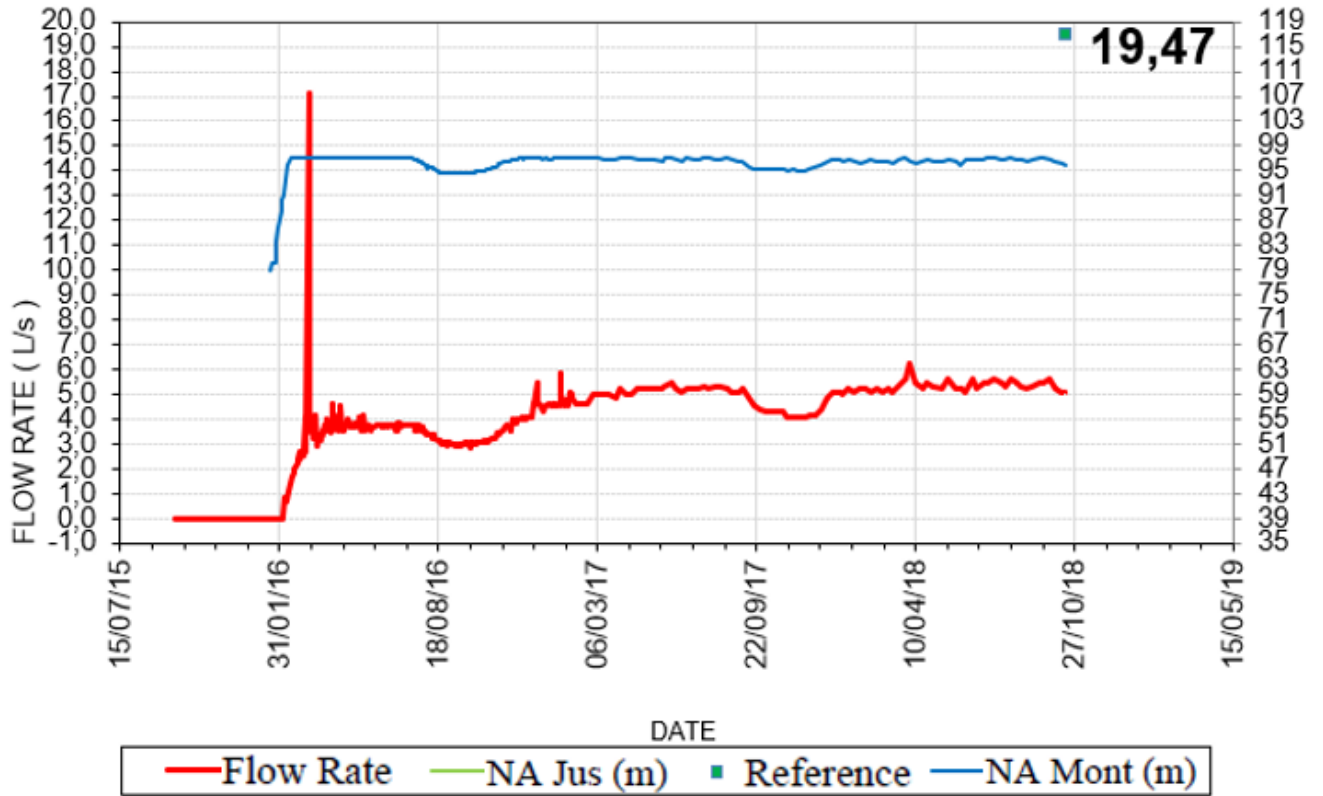
After analyzing the graphs of the flow meters where the reference value corresponds to the flow obtained from the numerical modeling, under operation regime (El. 97.00), increased by five. This value represents 50% of the flow calculated for the design of the internal drainage system of the structures. Figure 15 referring to dikes 01-A also registered in 2016 a peak flow very close to the reference value considered for attention. In Figure 16 representing dike 01-B until the year 2017, at least three instrumental readings showed a flow above the allowable reference for the structure. Along with these readings there was distortion in the piezometric data of the same structures, in close periods. When the same anomaly, non-conformity and / or manifestation outside the desirable appear simultaneously in both monitoring methodologies. Therefore, the dam safety situation is the most unfavorable and requires immediate emergency action. The flow meters of dike 01-C showed readings well below the reference for attention

Figure 15 - Flow reading in L / s of the flow meter (MV-D01A-01) of dike 01-A

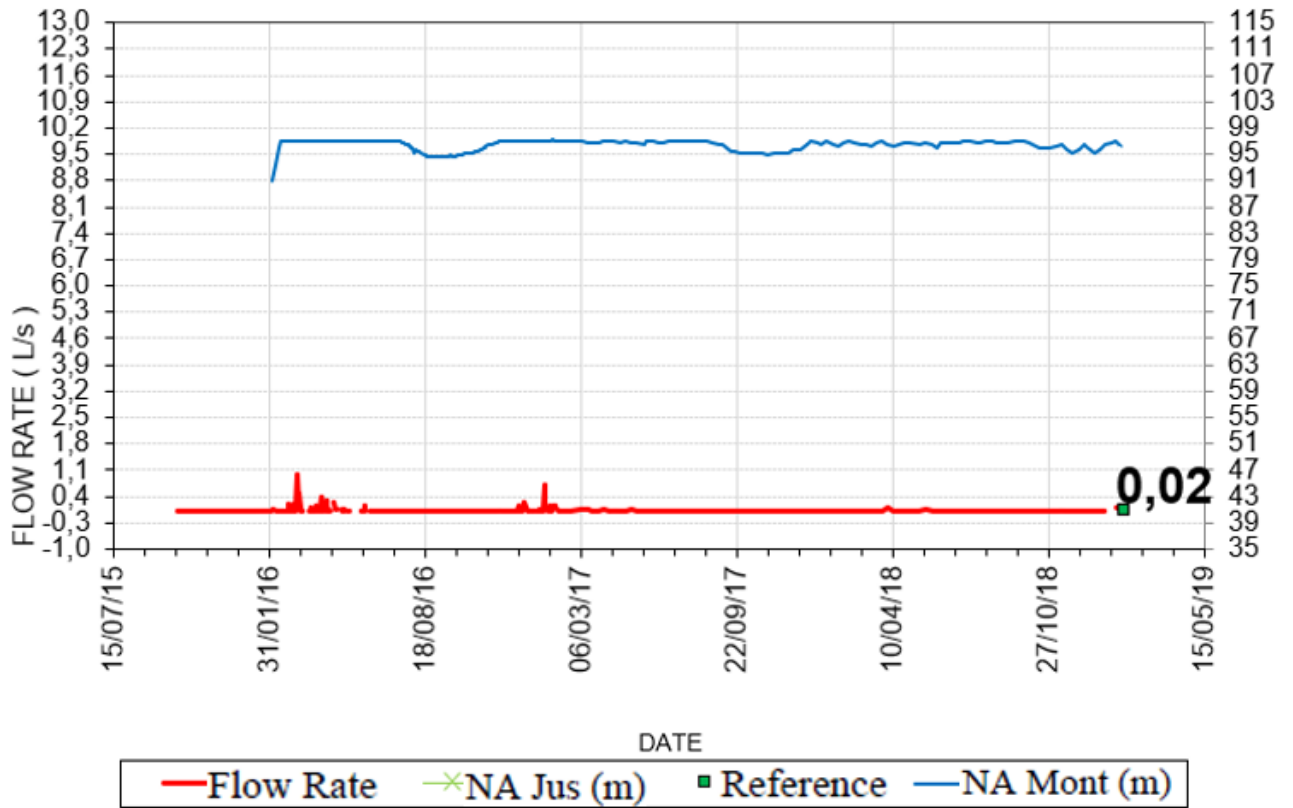
Figure 16 - Flow reading in L / s of the flow meter (MV-D01B-01) of dike 01-B
