Fatigue lifetime of a RC bridge along the Carajás railroad

The aim of this paper is to present and discuss the results obtained with a methodology used to characterize the concrete and to evaluate the structural safety against fatigue of the reinforced concrete bridge number 50A located in the Carajás railroad. An "in situ" inspection was carried out in order to assess the evolution of damage in structural elements, with reference to information available in existing projects, calculation memory and reporting of previous inspections. Extractions of concrete testimonies, alkalinity tests, sclerometry, pacometry and laboratory tests were also performed to characterize the materials mechanically and estimate the structural behavior of the bridge under higher future loads.

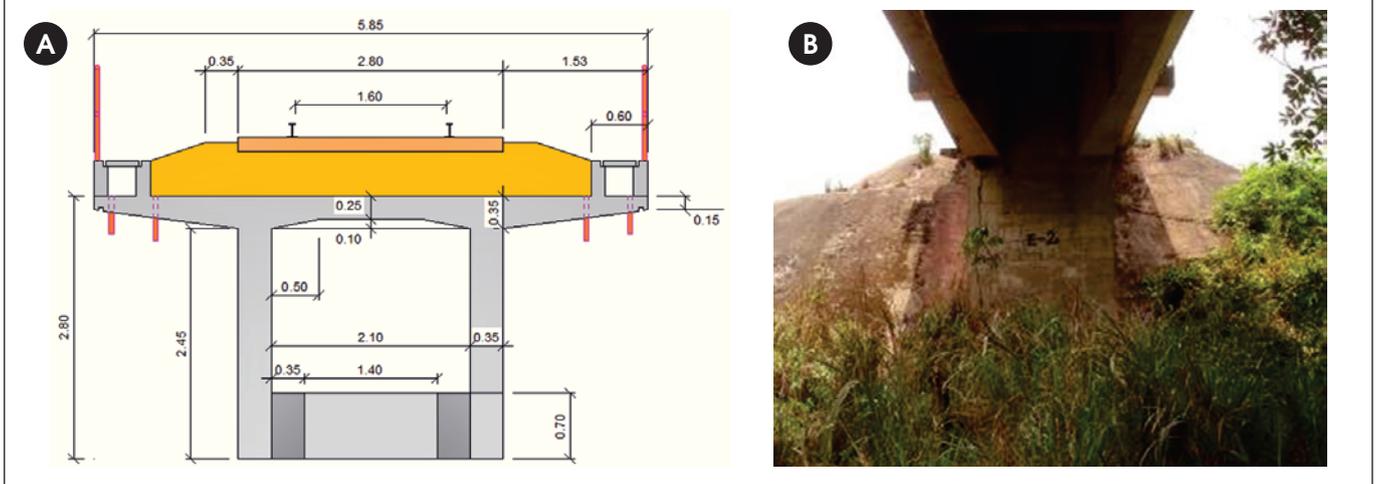
Figure 2 - (a) bridge's cross section (meters); (b) linear variation of the stringers' width close to supports

The superstructure is slab on beams type. The deck consists of four spans of continuous stringers of "pi" cross section, with linear variation of the web thickness from 0.35m to 0.70 m near the supports and block B2, as shown in Figure 2, stiffened by transversal beams (secondary) on chartered neoprene support devices at the abutment E1 and block B2. The beams are embedded in the abutment E2.

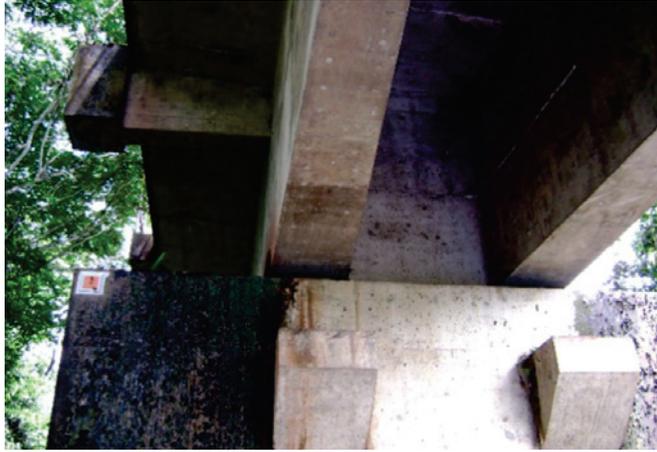
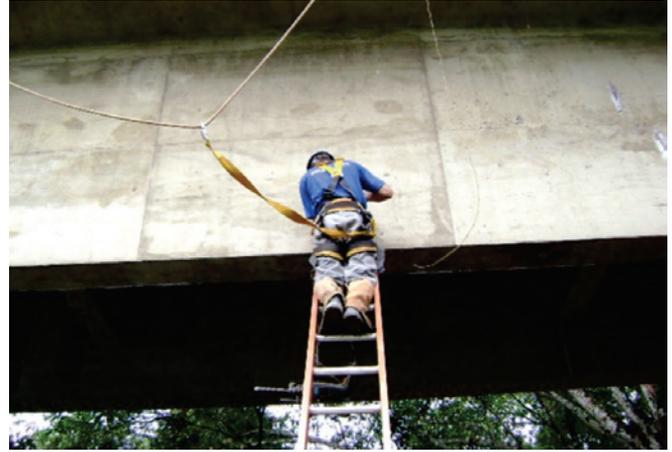
Figure 5 - Support (block) and instrumentation of the stringer

that the progression of cracking is an indication of symptomatic occurrence of a defect, it is believed that in this case, the cracks are the result of shrinkage of the concrete at early ages and that the differences could be related to the methodologies of measurement of these lengths. Efflorescence due to the dissolution of the compounds of the cement paste were also observed, according to Cascudo [2], infiltration, surface segregation and insufficient reinforcement coatings in concrete beams. On the crossbeams were also observed efflorescence and moisture stains. Generally, the stringers and crossbeams have satisfactory integrity, as shown in Figure 5.

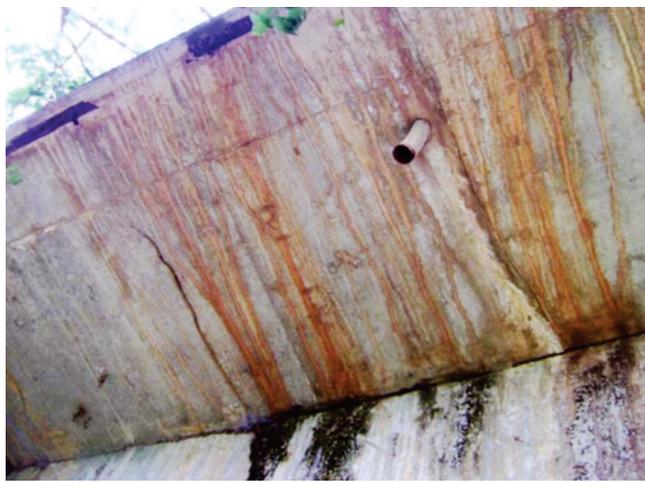
Figure 6 - Water infiltration and stains under the deck slab

During the inspection of the deck a heavy cracking pattern with efflorescence was noticed. On the stringers the presence of short or damaged drains led to the occurrence of moisture stains. Already on the side cantilevers were observed cracks with and without efflo-

rescence and infiltration, as shown in Figure 6. In the transition slab were not observed gaps, being therefore in satisfactory conditions. The design of the structure according to the available information in the calculation history was performed using the compressive strength of concrete corresponding to 18.0 MPa. For the foundations, was admitted concrete with compressive strength of 15.0 MPa and land with admissible stress of 0.8 MPa. The criteria used were based on the NBR 6118 : 1978 [3] to be the design code at the time of preparation of the project.

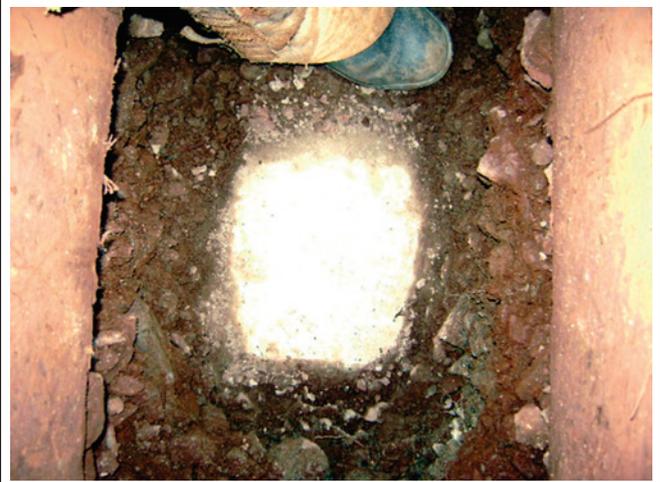
Figure 7 - Slab concrete surface preparation for instrumentation

In this last inspection were inspected areas of the upper face (0.3 mx 0.3 m), where it was possible to remove the gravel ballast, and bottom face of the deck slab with the aid of a stair, as shown on Figure 7, and the existence of cracks was not verified on these surfaces. In Figure 8, it can be seen that the support devices of the abutment E1 shows no visible abnormalities, only natural strains

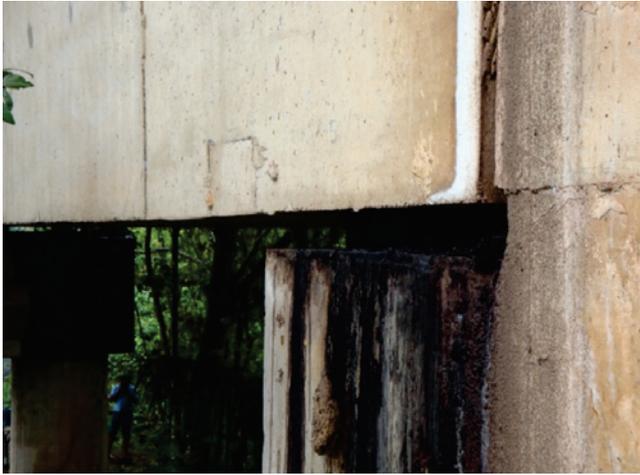
Figure 8 – Support device of the abutment E1

due to usage and dirt. Other support devices are under similar conditions to the support device of the abutment E1, but still suitable for use.

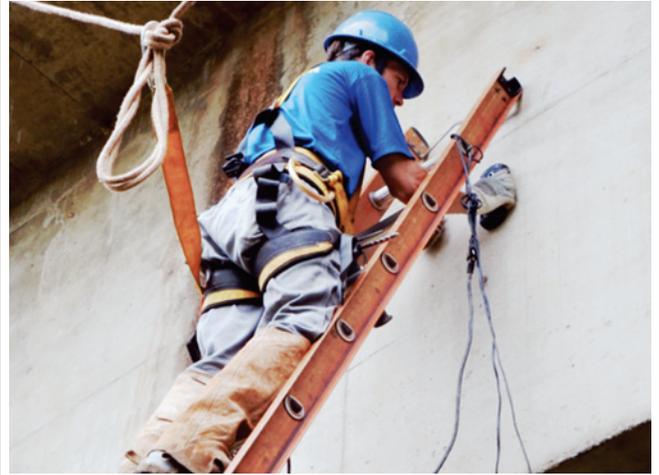
Figure 10 – Pacometry testing on stringer

The pacometry test was performed before the sclerometry tests to determine the position of steel bars for both the sclerometry tests and for instrumentation of the reinforcements with strain gages (EER). In this investigation a pacometer was used and its operating principle is electromagnetic, to determine the presence and direction of the bars, as well as to determine the thickness of the concrete coatings in relation to the external surface of the bars. Figure 9 shows the pacometry testing on caisson T7 and, in Figure 10, on a stringer. The spacing between bars varied from 0.05 m to 0.11 m. Pacometry tests were also carried out on the deck slab for steel bars detection to avoid damage during the testimony extractions.

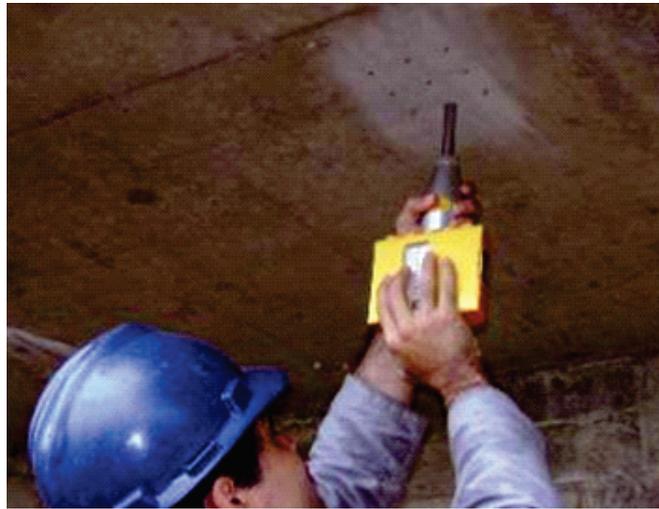
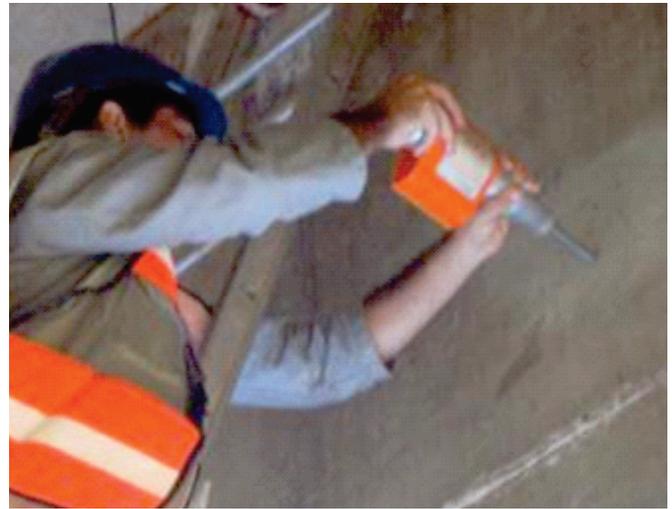
Figure 11 - Sclerometry testing on slab (left) and stringer (right)

The sclerometry tests were performed on all structural elements of the bridge. This method basically consists in evaluating the superficial hardness of the hardened concrete using a device which measures the energy of impact on the reflection surface. The method known as “rebound hammer method” provides an index (denominated sclerometric index) having direct correlation with the compressive strength of concrete. However, there are several

studies that point to other factors that affect these correlations outlined by the calibration curves. According to Evangelista [5] factors as the amount of cement, aggregate nature, maturity and moisture content, carbonation and surface finish, can increased propagation of errors in the results. The concrete strength was estimated based on the arithmetic average of the resistances of nine points of each study area (0.10 mx 0.10 m), according to NBR 7584 : 1995 [6]. Figure 11 shows the application of sclerometer and arrangement of the points on the deck slab and stringer.

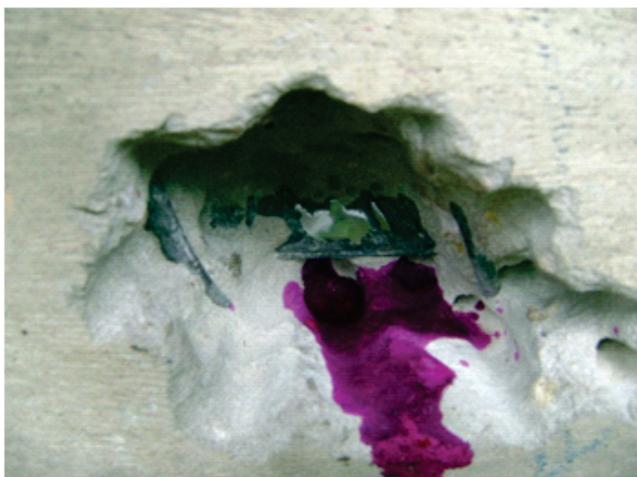
Figure 12 - Final aspect of the stringer's concrete after alkalinity testing

ements of the OAE using a solution with the chemical indicator phenolphthalein were performed "in situ". After opening of the windows in 0.05 m thick concrete coating, the tests were conducted in various structural elements and showed that the concrete is at a satisfactory level of alkalinity, with no visible sign of corrosion. Figure 12 shows the final appearance of the concrete after the alkalinity testing (pink color indicates the

alkaline concrete with no carbonation).

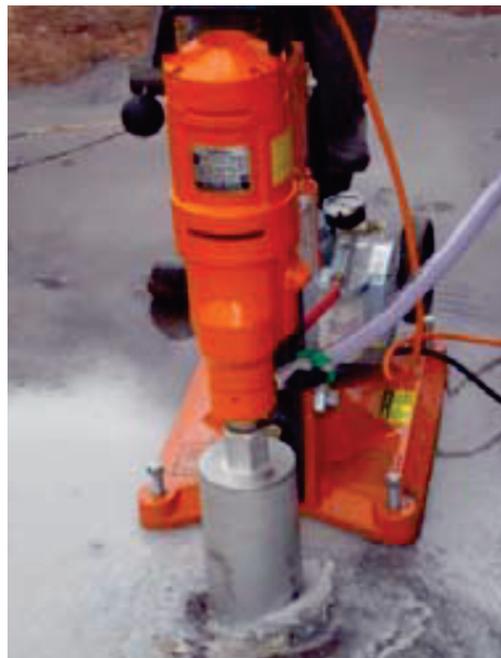
Figure 13 - Concrete testimony extraction

To determine the mechanical properties of concrete testimony were extracted from the structural elements by using a cutting machine with rotary diamond crown shown in Figure 13. A total of five concrete testimonies, two from the abutments, two from the slab and two beam from the stringer. The testimonies that had flaws in their end faces, due to the extraction process were rectified with the aid of a circular saw, resulting in a final length of 200 mm, as shown in Figure 14. Regarding the tests to determine the modulus of elasticity and compressive strength of concrete, the testimonies were tested following the recommendations of NBR 8522 : 2003 [7] and NBR 5739 : 1994 [8], where

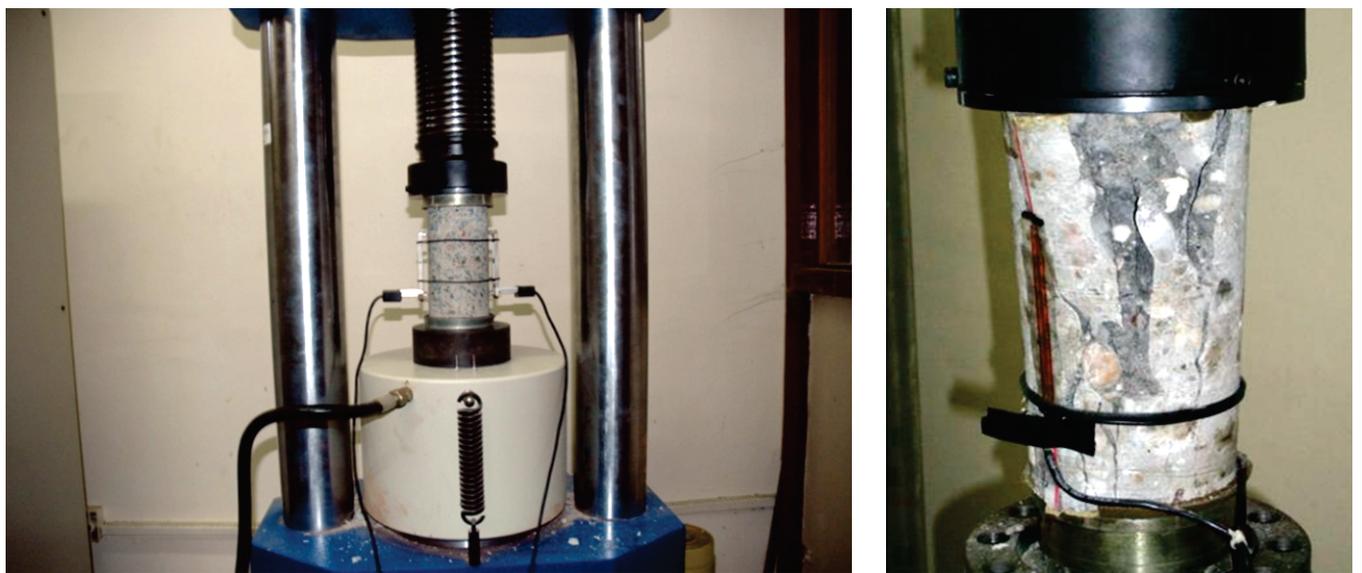
Figure 15 – Concrete elasticity modulus determination

the first recommended to be realized three cycles of loading and unloading with peaks corresponding to 30% of the failure stress (f_c) and 0.5 MPa . For this a servo-controlled machine model PC-200CS, manufacturer EMIC, was used. Tests were then performed with constant load speed rate of 0.25 MPa/s. After the cycles of loading and unloading, a loading was applied progressively until failure by crushing of the testimony. In addition to the strain sensor type "clip gauge", still from the manufacturer EMIC, two strain gages acquired from the company Excel Sensors Ltd., Model PA-06-201BA-120L, were installed at half height of the testimony and diametrically opposed. Figure 15 shows details of the tests in the laboratory.

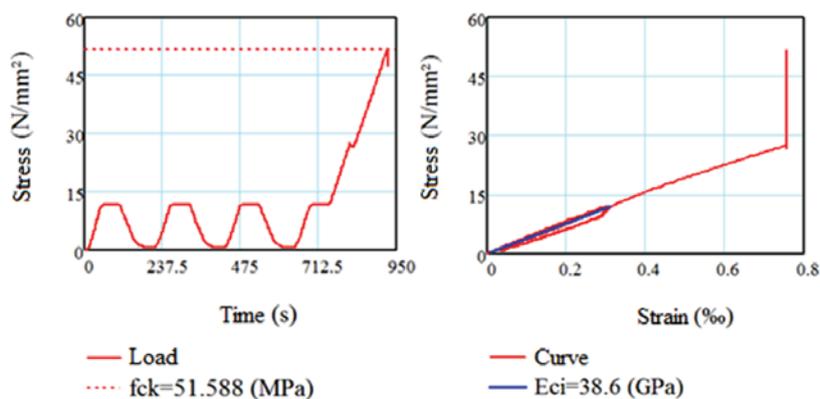
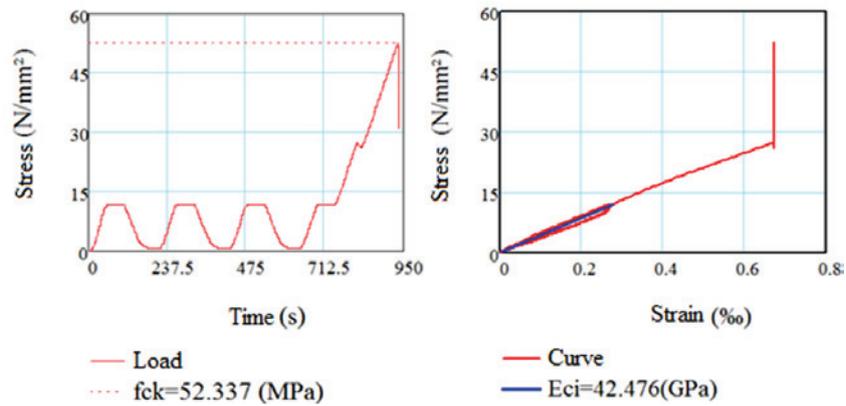
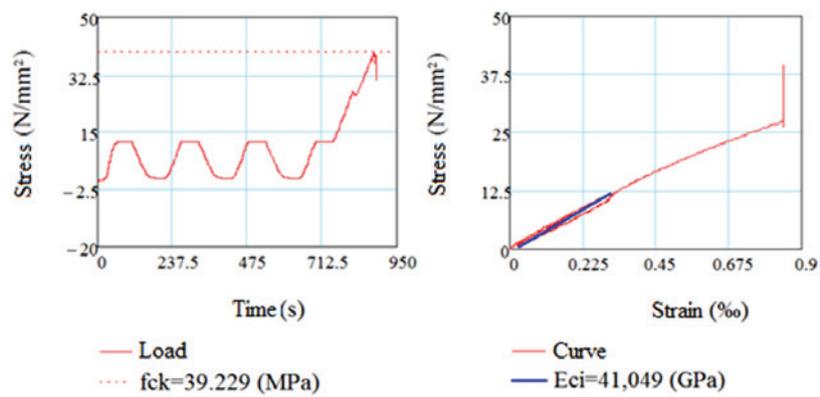
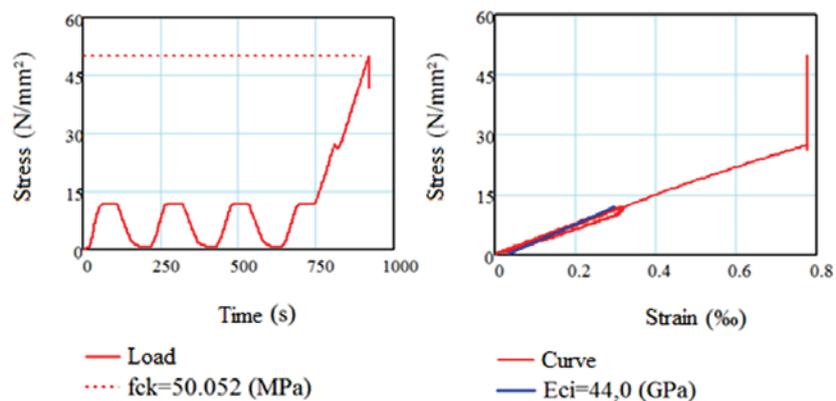
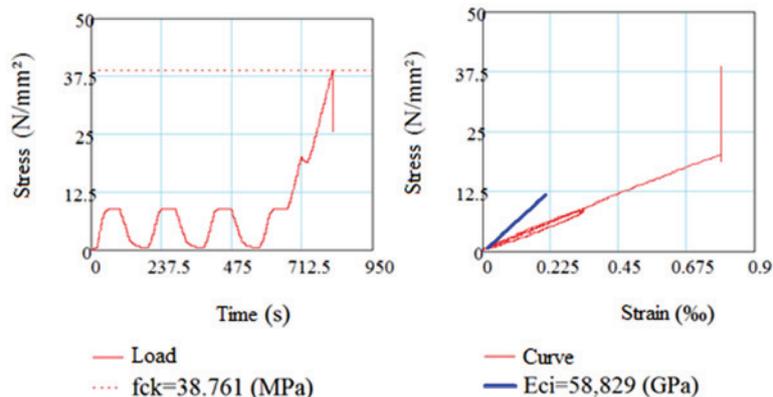
Figure 16 - Stress-time and stress-strain diagrams for abutment E2, CP01

Figure 17 – Stress-time and stress-strain diagrams for abutment E2, CP02

Figure 18 – Stress-time and stress-strain diagrams for deck slab, left side, CP01

Figure 19 – Stress-time and stress-strain diagrams for deck slab, left side, CP02

Figure 20 – Stress-time and stress-strain diagrams for the left side stringer

In Figures 16 to 20 it can be seen the result of the configuration adopted for the tests as a function of time, where the loads ranged from 0.5 MPa to 30% of the failure stresses estimated for the concrete testimonies according to the current code prescriptions, and the stress-strain diagrams generated as the tests were performed.

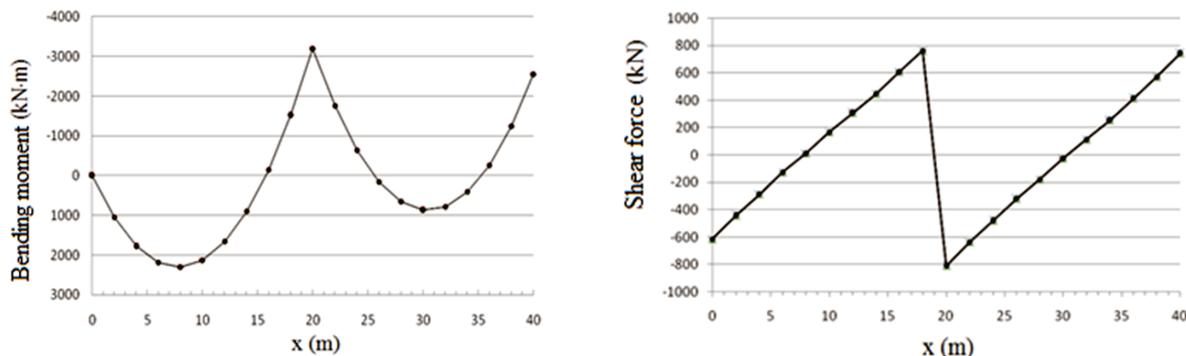
Figure 21 – Bending moment and shear force characteristic values

For the determination of the applied loading on the stringers (bending moment and shear) each of the spans was subdivided into ten parts, resulting in 21 sections, as done in the calculation memory. As illustration, the forces' variation from SAP200 [10] for section 21 is presented, corresponding to the fix point between the deck slab and abutment E2 and considered the most requested section under several trains types passage without permanent loads. The other sections time histories were also obtained, but only their envelopes are presented. Figures 22 to 25 show the dynamic loading history for several trains.

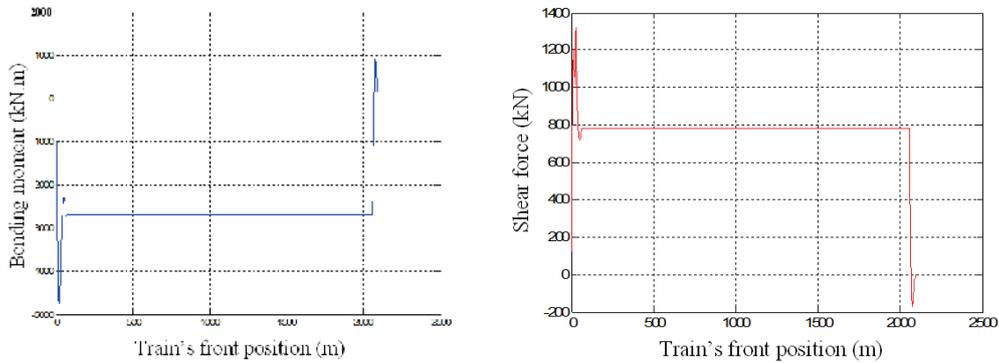
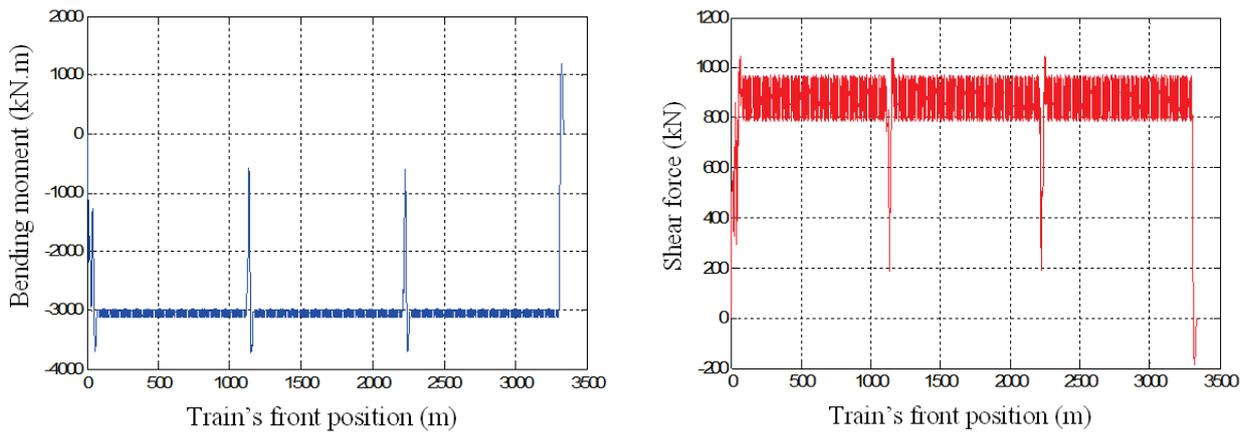
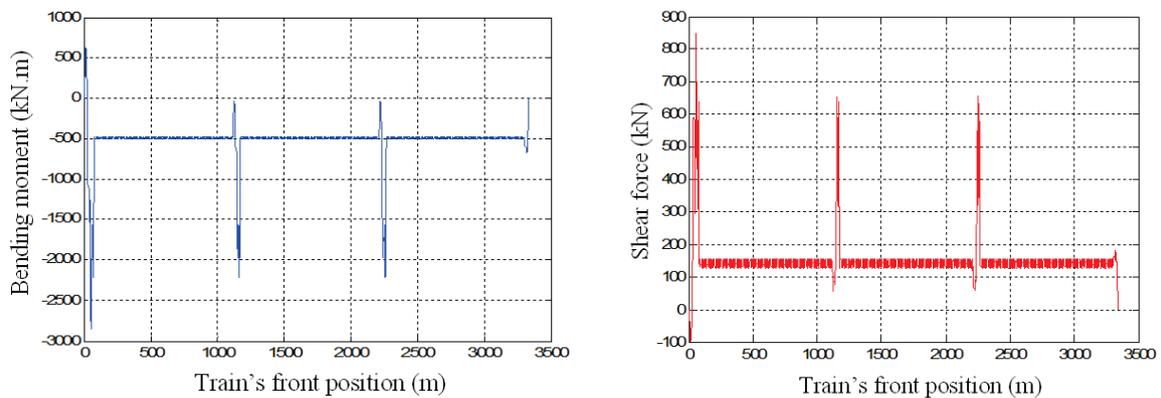
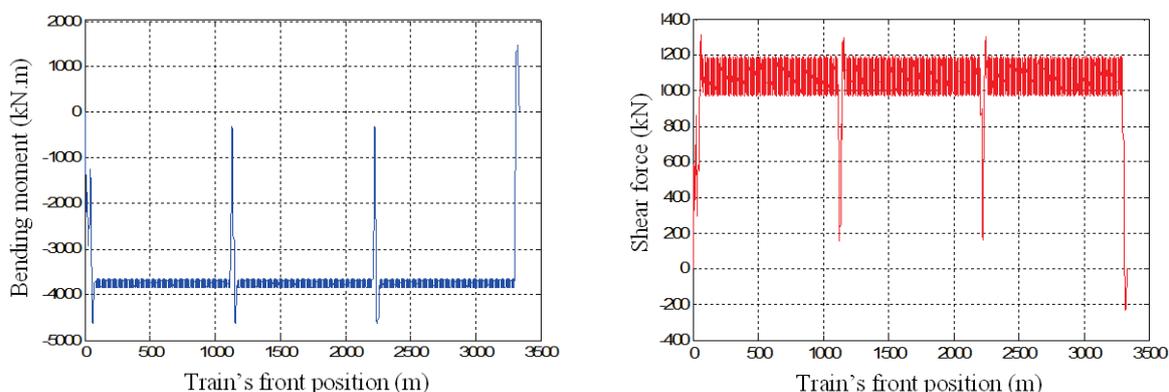
Figure 22 – Bending moment and shear force history for section S21 under Cooper E80 train type passage

Figure 23 – Bending moment and shear force history for section S21 under loaded operational train type passage

Figure 24 – Bending moment and shear force history for section S21 under unloaded train type passage

Figure 25 – Bending moment and shear force history for section S21 under loaded future train type passage

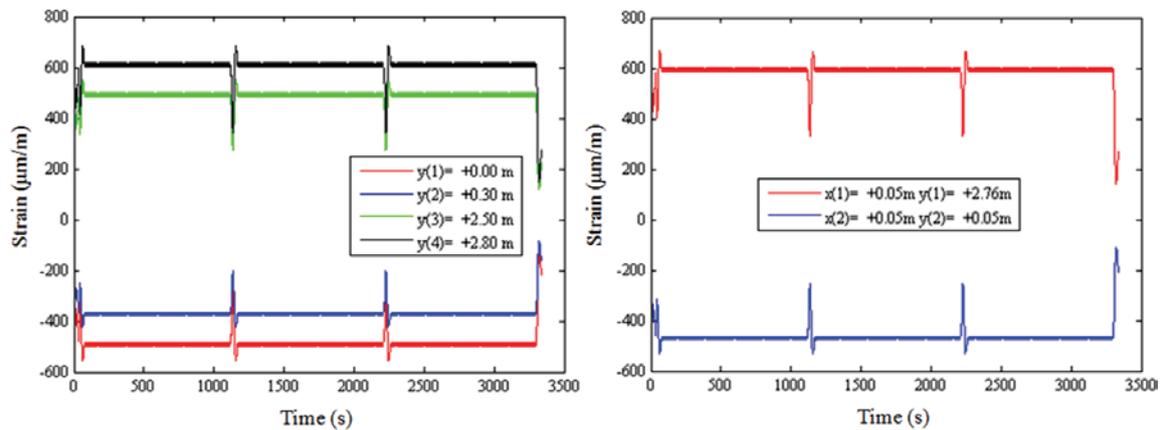
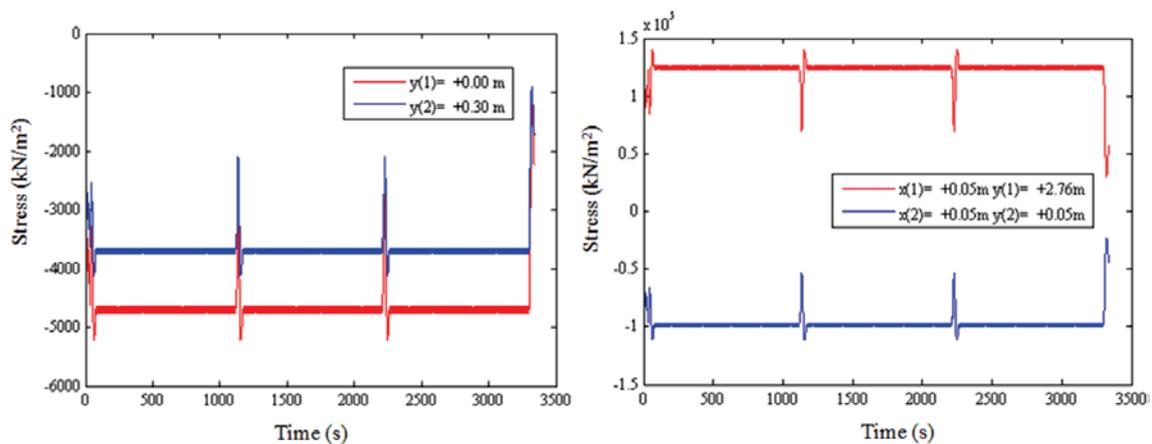
To determine the fatigue lifetime of the stringers was considered, initially, the variation of bending moment due to train operational loaded, future loaded and unloaded. From the variation of bending moment, it is possible to determine the strains and stresses at any point of the cross sections. Figure 26 shows theoretical variations of the strains, respectively, in the concrete and reinforcement of the section S21 due to the passage of the train operational loaded. The coordinates indicated in the legend of the Figure 26a indicate the position (height) of the concrete fiber analyzed in relation to the lower face of the section. According to NBR 6118 : 2003 [11] and Model Code MC90 (CEB-FIP, 1992) [12] should be estimated minimum and maximum stresses in an area not exceeding 300 mm from the edges of the cross section. For this reason, in the figure are shown four curves corresponding to the fibers located 300 mm from the upper and lower edges of the stringer. Since Figure 27 shows respectively the theoretical compression stresses in the

concrete and in the reinforcement of the section S21 due to the passage of the train type operational loaded.

Figure 26 – Stringer's strain theoretical variation in section S21 due to passage of the loaded operational train type on concrete (left) and reinforcement

Figure 27 – Stringer's stress theoretical variation in section S21 due to passage of the loaded operational train type on concrete (left) and reinforcement

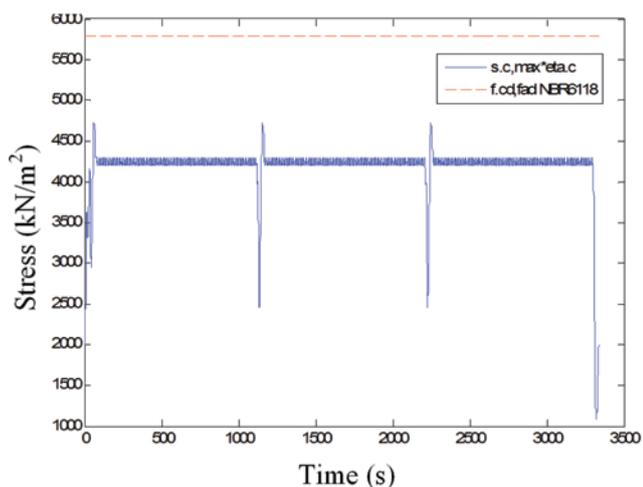
Figure 28 – Concrete rectified stress and limit fatigue stress according to NBR 6118 : 2003 (11)

For a preliminary check to fatigue of concrete were considered the prescriptions of NBR 6118 : 2003 [11]. According to this standard, checking the fatigue of concrete is ensured if the maximum compressive stress in concrete (corrected for the gradient of compressive stress) does not exceed a limit fatigue stress $f_{cd,fad} = 0.45 f_{cd}$. This check is presented in Figure 28, where the rectified stress is provided in module (with positive sign indicating compression, in this case). Whereas the design compressive strength for the concrete, i.e. $f_{ck} = 18$ MPa and a safety coefficient $\gamma_c = 1.4$, the fatigue limit stress is $f_{cd,fad} = 5.78$ MPa. Thus, according to NBR 6118 : 2003 [11], only the stresses arising from the permanent load would already be very close to this limit in section S21. It should be remarked that this criterion is quite conservative, since it does not consider the stresses variations.

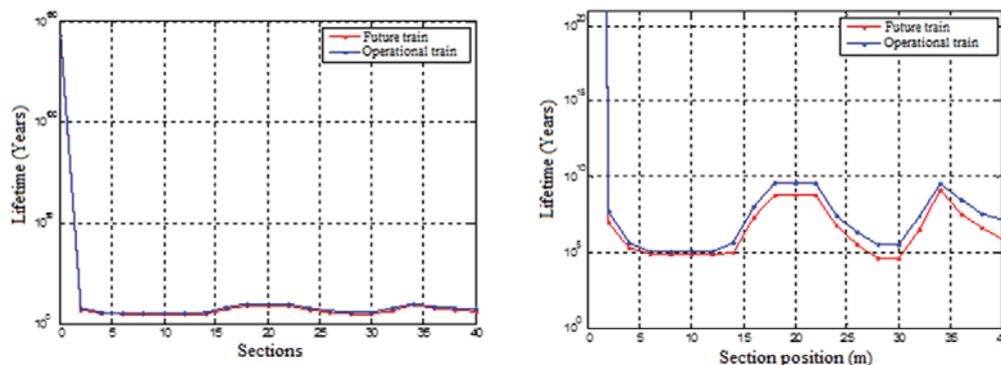
Figure 29 – Fatigue lifetime analysis considering f_{ck} from calculation memory

ment loading and is under great stress variations when the moving loads act. Because of this, the lifetime of the section is $1.33E +07$ years approximately, for the operational train, and $7.05E +05$ for the future train type.

Must be remarked that these lifetimes were estimated using the specified characteristic strength of concrete in the project ($f_{ck} = 18$ MPa). The other sections were also analyzed for fatigue and the results regarding lifetime are presented in Figure 29 (semi log scale), considering also the f_{ck} specified in the project for both operational and future trains. Figure 29 shows that occurs a reduction in the fatigue lifetime of the sections with the change of loading from operational to future train type. It is also observed that the lifetime of the sections located on the first support is very high (support at the abutment E1, section S1, $x = 0$ m) which did not occur in the third support sections (section S21, $x = 40$ m). In section S21 the critical element (suffering greater fatigue damage) is the concrete on the bottom surface. Therefore, based on the results obtained for other bridges already analyzed (bridges over the rivers Mearim, Cajuapara and Rio Vermelho), it is known that the real compressive strength of concrete is much higher than the value specified in the project. Thus, one must be considered the
