Shear strength of reinforced concrete one-way ribbed slabs

Resistência ao cisalhamento de lajes nervuradas unidirecionais de concreto armado

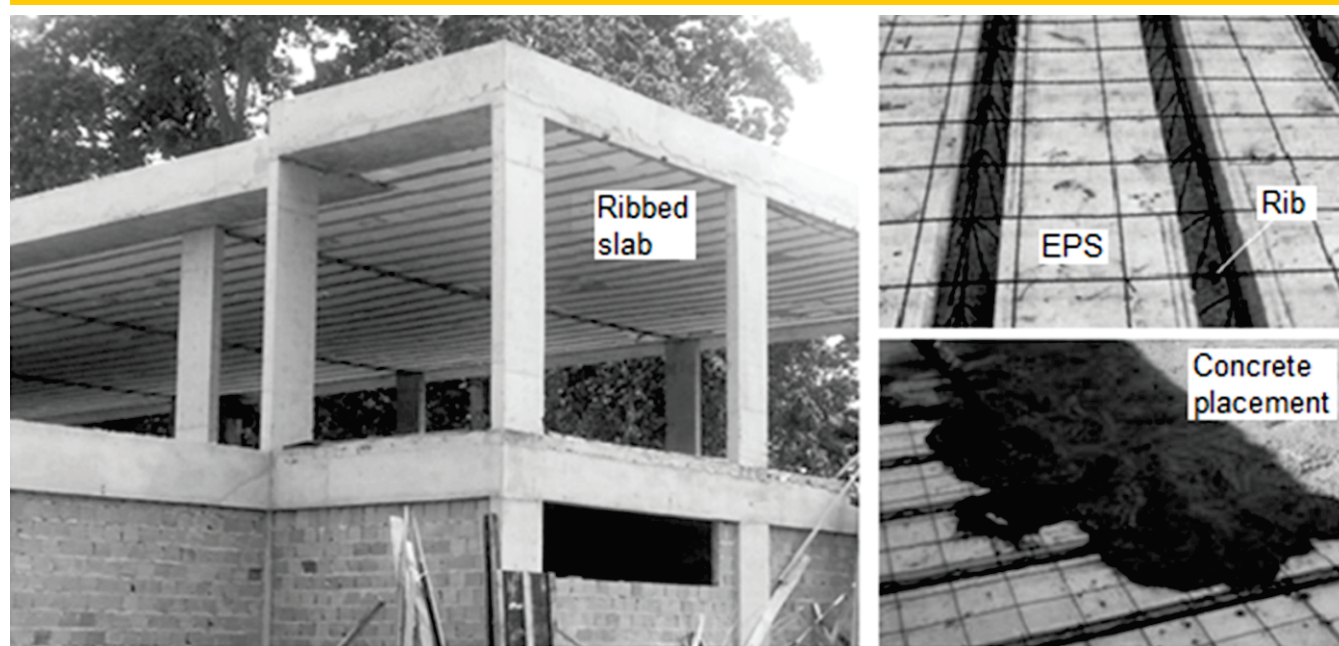
Figure 1 – One-way ribbed slab

The Brazilian standard for reinforced concrete structures, NBR 6118 [2] defines ribbed slabs as reinforced concrete plates with a table supported by ribs, linking them and matching their displacements. The ribbed slabs are designed as a set of T beams slightly

spaced from each other, as shown in Figure 1, and it is this spacing between the ribs which governs the shear design of the slab.

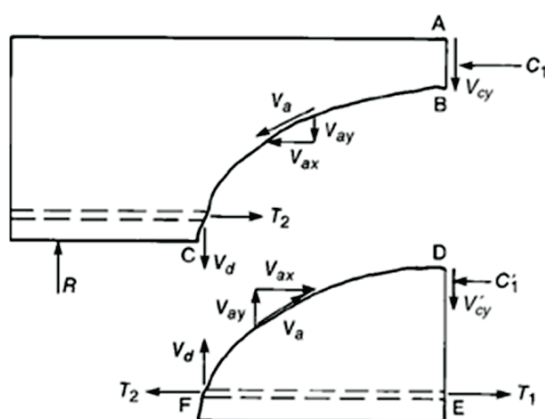
Figure 2 – Forces along an inclined shear crack (MACGREGOR, 1997)

- V_{cy} - Non cracked concrete
- V_a - Aggregates interlock
- V_d - Longitudinal reinforcement dowelling
- C - Compressive balance force
- T - Tensile balance force

stirrups, has the ability to resist to a certain shear force. MACGREGOR [5] shows the contribution of various components of the mechanisms of shear strength of beams without shear reinforcement, except the part on arch effect, as shown in Figure 2. When the structure is loaded, the shear is transferred in part through ABC line by the mechanisms of resistance of concrete: not cracked concrete (V_{cy}), friction of aggregates (V_a) and the longitudinal reinforcement dowelling (V_d). Immediately after the bending cracks inclination, between 40% and 60% of the total shear strength is resisted by the combined strengths of V_d and V_{cy} . Considering the DEF part of the cracked structure and assuming the moments with respect to point E, it follows that V_d and V_a cause moment at point E, which should be balanced by the compressive force $C'1$. The balance of the resulting horizontal section ABDE shows that $T1=C1+C'1$ and, finally, $T1=C1+C'1$ must balance external moment in this section.

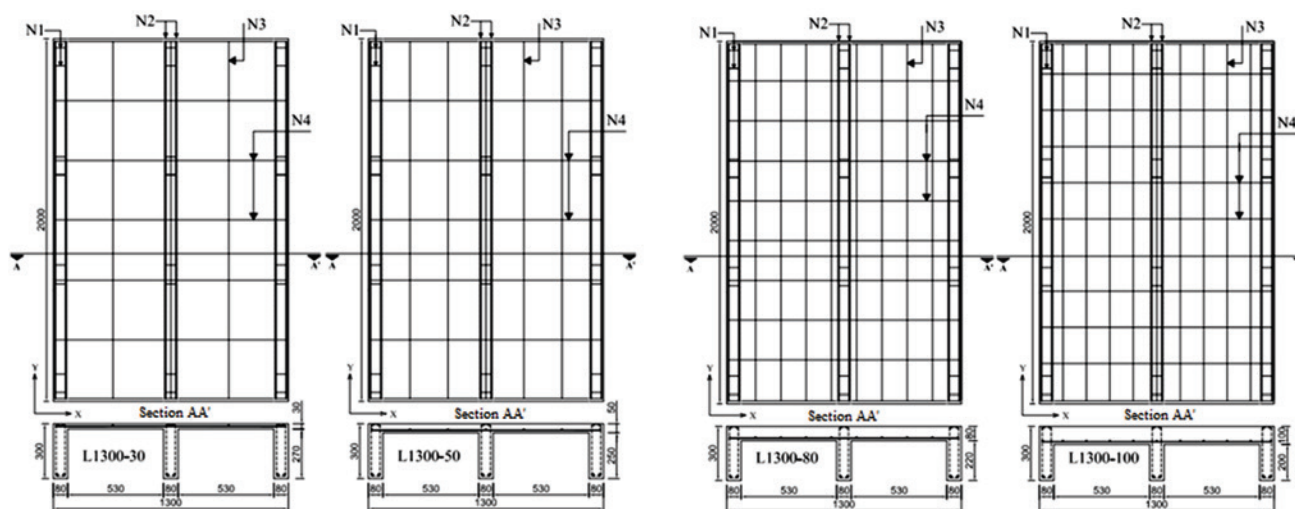
Figure 3 – Reinforcements of the L1300 group of slabs

2 N1=5.0c100; 2 N2=12.5-1980; 5, 7, 10 and 11 N3=5.0-1980; 7, 7, 10 e 11 N4=5.0-Var.

and facilitates the assembly of the longitudinal bars shown in Figures 3 and 4. Figure 5 shows details of the reinforcement of the ribs, where it is possible to observe clearly the position of the stirrups composition and the distances between supports

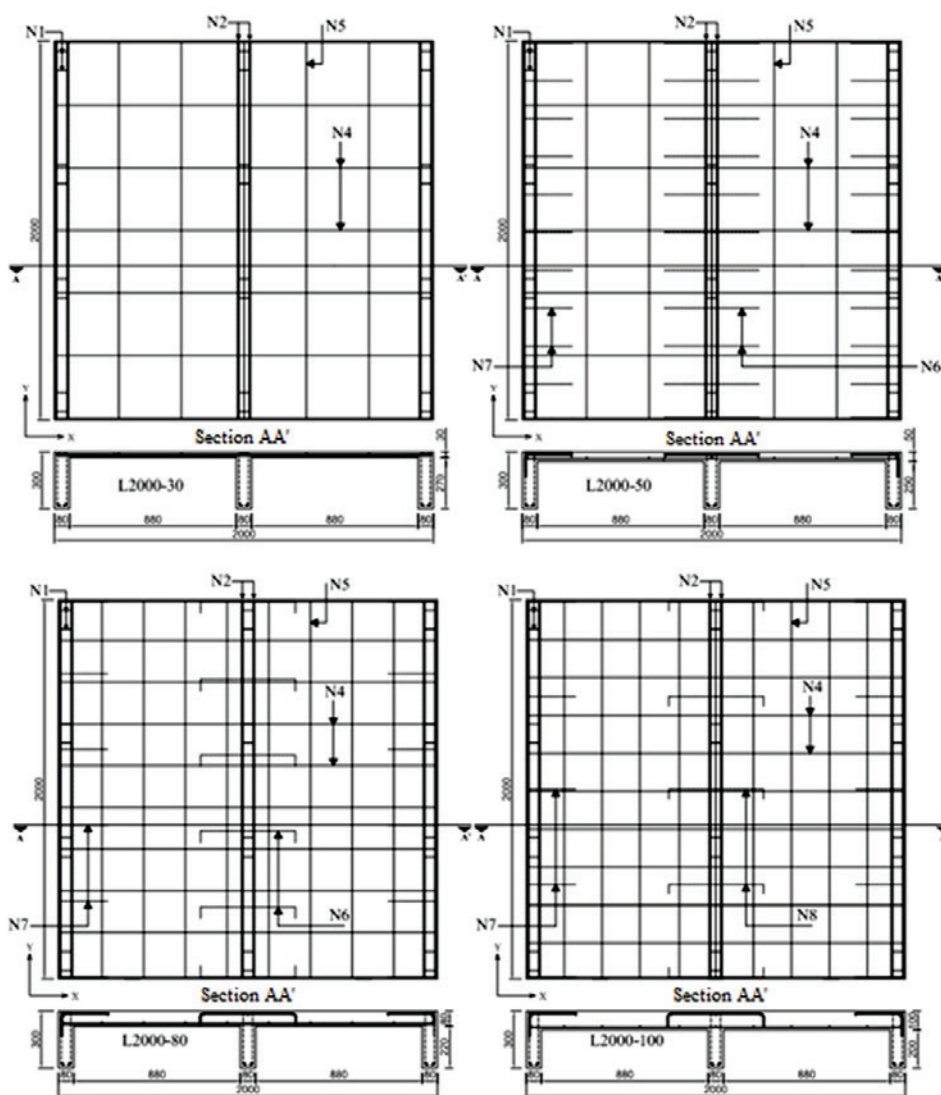
Figure 4 – Reinforcements of the L2000 group of slabs

7, 7, 10 e 11 N5=5.0-1980; 11 e 6 N6=5.0-500; 11, 6 e 5 N7=5.0-350; 5 N8=5.0-650

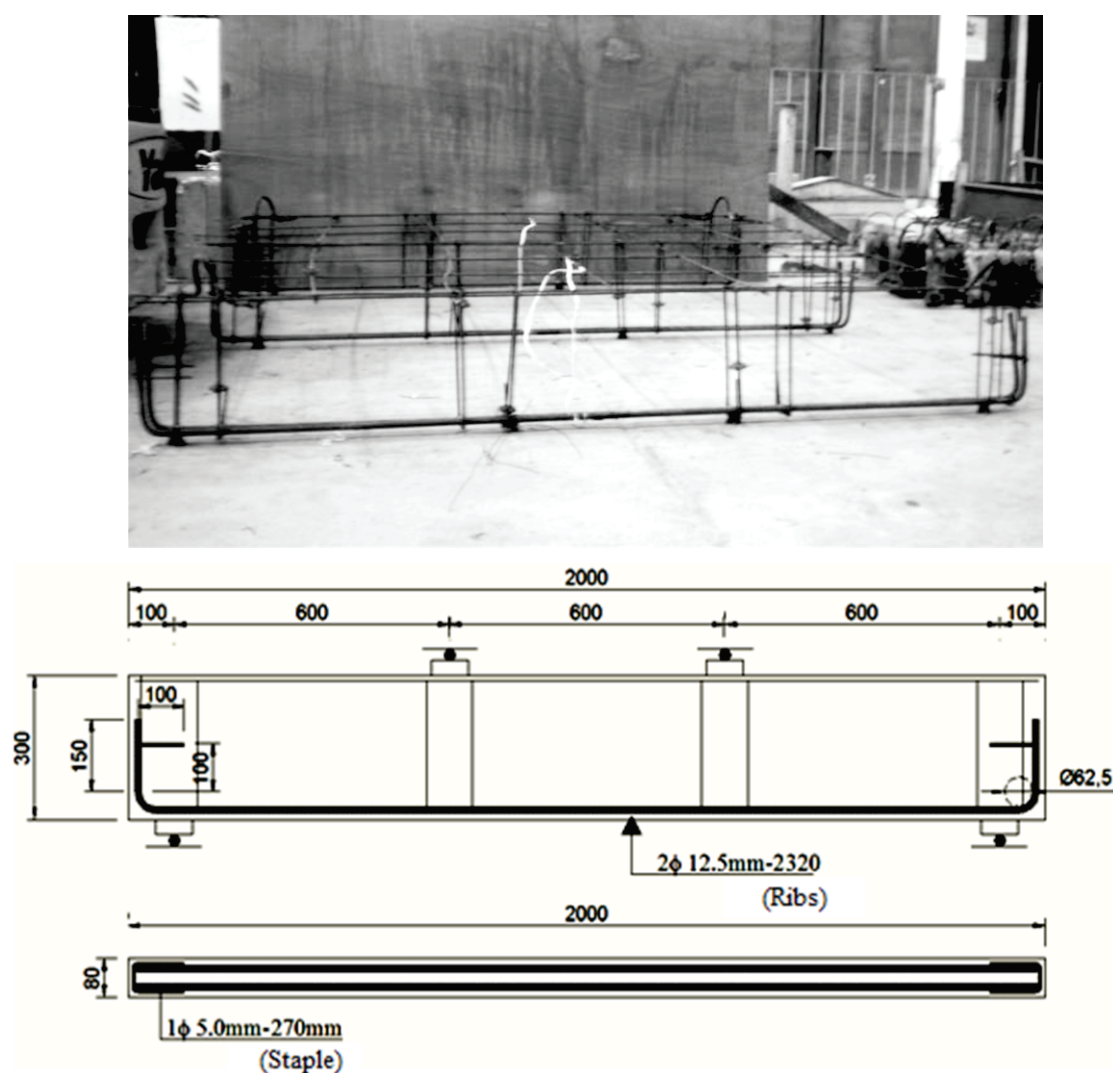
Figure 5 – Ribs' reinforcements

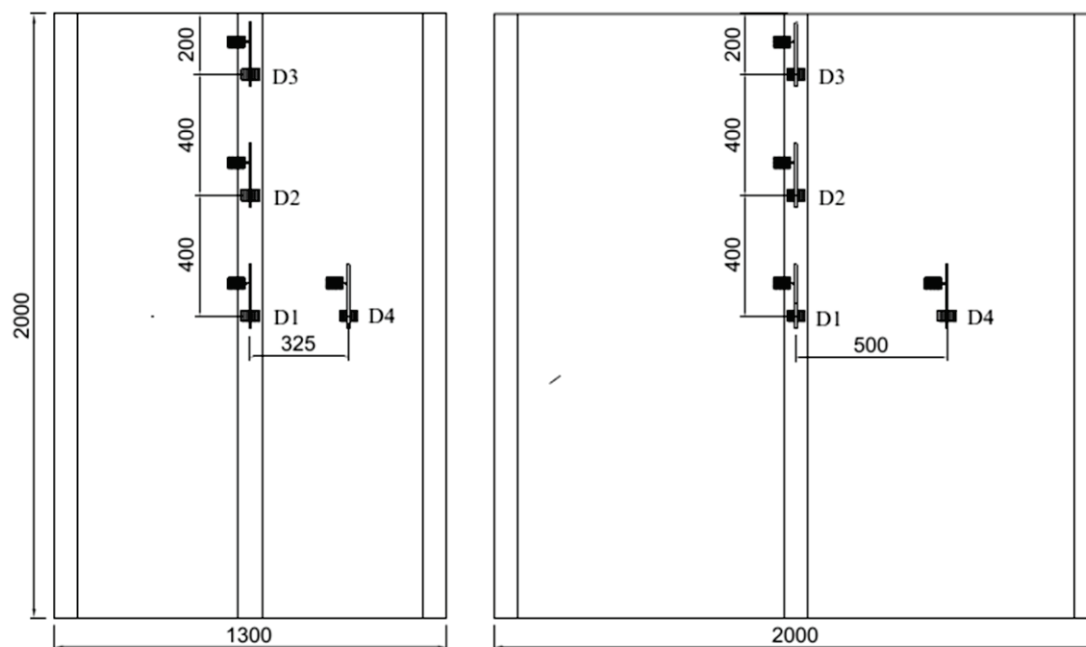
Figure 7 – Dial gauges' distribution on the slabs

The reinforcements' strains were monitored using electrical strain gauges (EERs) manufactured by Excel Sensors with grid dimensions $(3.18 \times 3.18) \text{ mm}^2$ - model PA-06-125AA-120L, which were installed on the steel bars. The concrete's strains at the top surface of the slabs were also monitored with electrical strain gages (EERs) from the same manufacturer - model PA-06-201BA-120L. Strains in the ribs along the longitudinal direction were monitored at mid-span and on the table in the transverse direction. The strain gauges were positioned in regions that showed greater tensile stress for flexural and composition reinforcements, and compression of the upper face of the concrete slabs (Figure 6). Already the displacement measurements were obtained from gauges positioned on the bottom surface of the slab (Figure 7). These gauges were digital comparators watches of Digimess brand, with maximum course of

50 mm and reading accuracy of 0.01 mm, and were supported in auxiliary structures without contact with the test system.

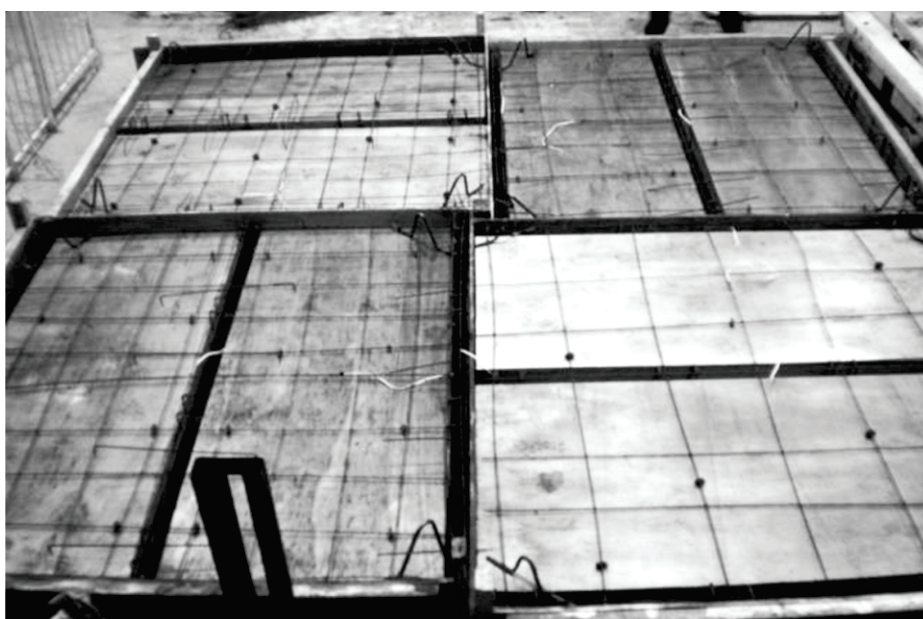
Figure 8 – Ribbed slabs ready for casting

The waffle slabs were made in two stages, the first of which were molded slabs of L1300 group and, in the second, slabs of L2000 group. The slabs molds were of compressed sawed wood pound of 10 mm thick. Then, the reinforcements were carefully positioned and mounted in the molds with the aid of plastic spacers, including negative and assembly reinforcements (stirrups of composition and staples) in order to keep the planned useful height for all slabs, as shown in Figure 8.

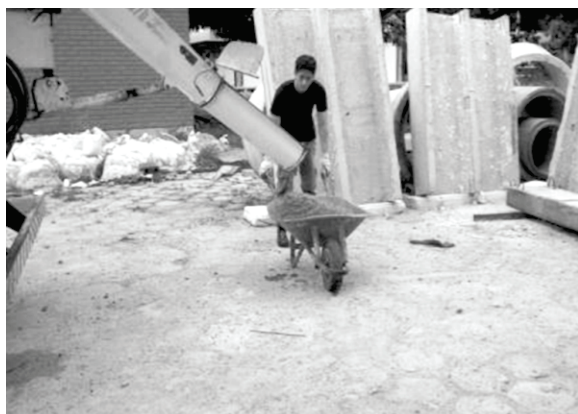
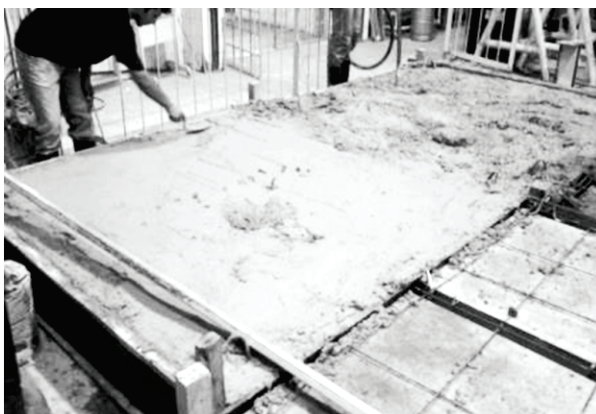
Figure 9 – Concrete placement and slabs' surface regularization

The monitoring of the ribs' longitudinal and distribution reinforcements was performed at points defined according to design specifications, receiving a preparation before gluing for removal of surface irregularities with rasp tool. After surface cleaning, the gages were bonded with adhesives based on epoxy and, after welding of connecting cables to terminals, were also protected with resin-based epoxy to later be surrounded by isolating tape. The casting of the slabs was carried out from commercially supplied mixed concrete whose compression strength of 30 MPa at 28 days was applied, with rolled pebble of 19 mm of maximum diameter. It took an approximate volume of 3 m^3 of concrete for the slabs and proofs, also considering possible losses. The concrete placement was completed with the regularization of the surface and removal of the excess material (Figure 9). While

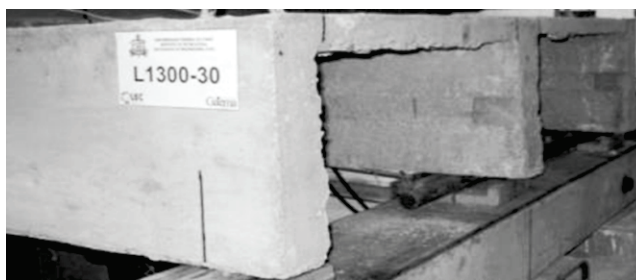
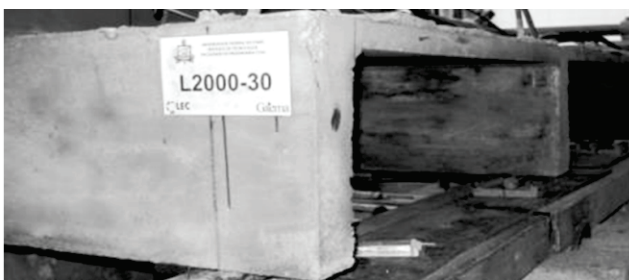
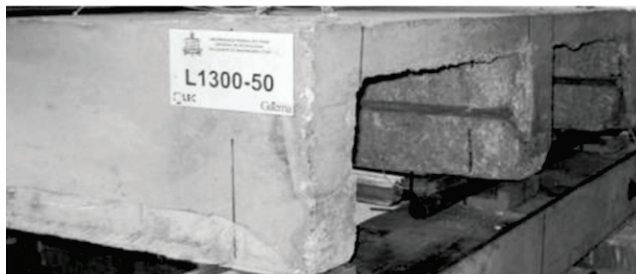
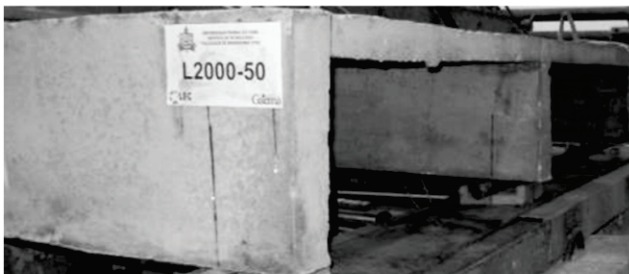
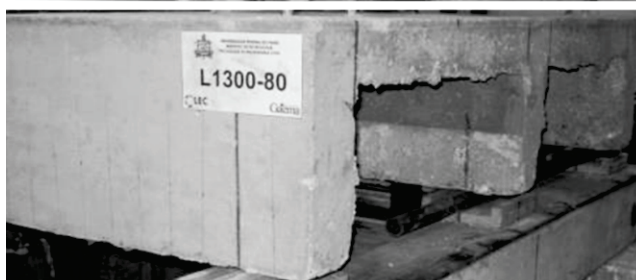
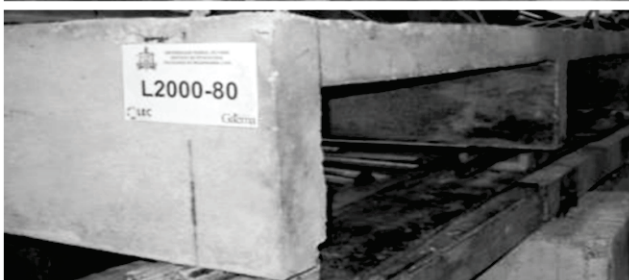
Figura 10 – Groups L1300 e L2000 of slabs with different tables' thickness

the slabs casting, 18 cylindrical proofs with dimensions of 100 mm diameter and 200 mm in length for the tests to obtain the mechanical properties of concrete were cast. The curing of concrete took place in a laboratory environment for 7 days, made with regular wetting. Figure 10 shows the identified and stored slabs before tests.

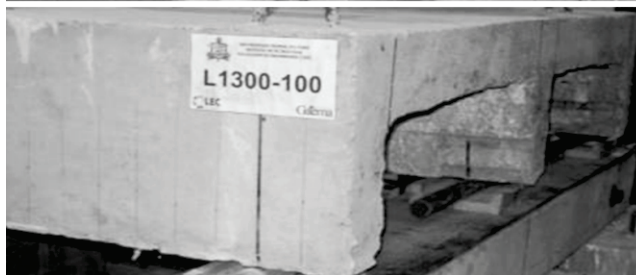
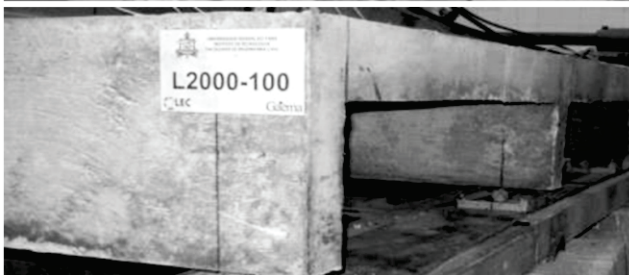
Figure 11 – Test system

The test system was mounted on the reaction slab at the Civil Engineering Laboratory (LEC) of the Federal University of Para (UFPA) with the main objective to obtain the response of the structure to the distributed load applied transversely to the ribs. Thus, the slabs were tested using auxiliary devices with rollers over bearing blocks, supporting the load applied perpendicular to the longitudinal axis of the ribs, on the upper surface of the panel, through a simply supported steel beam for loading distribution in two points simulating a simple flexure situation, coupled to a steel frame on the reaction concrete slab, according to Figure 11.

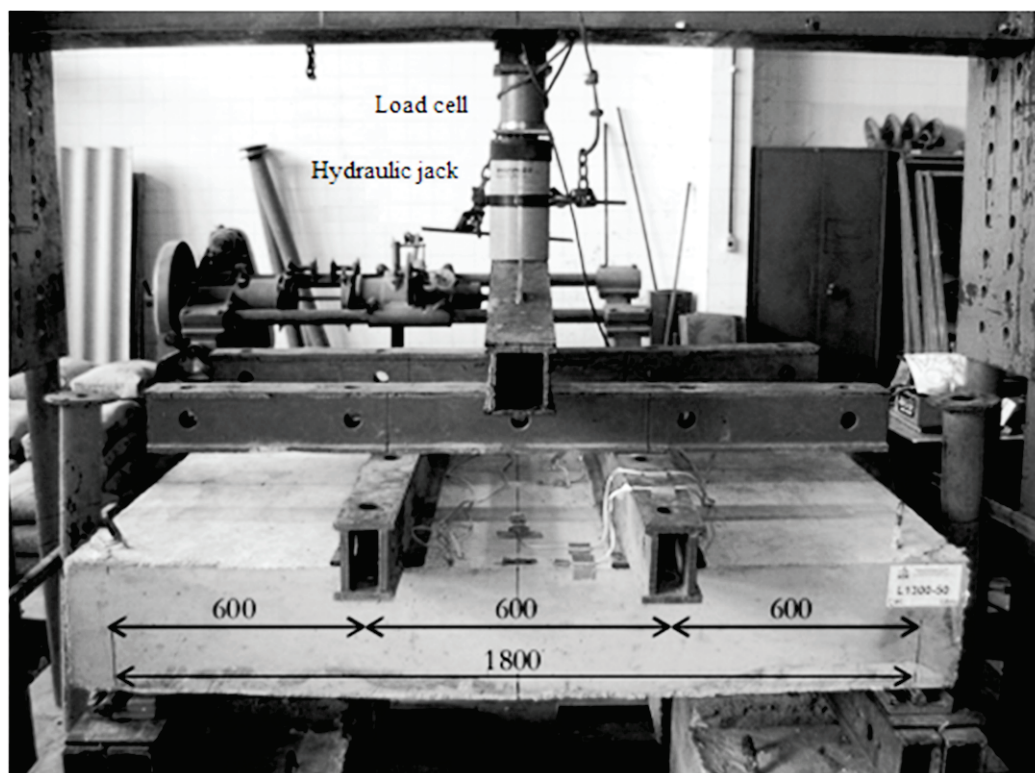
and points of application of load (Stuttgart test system).

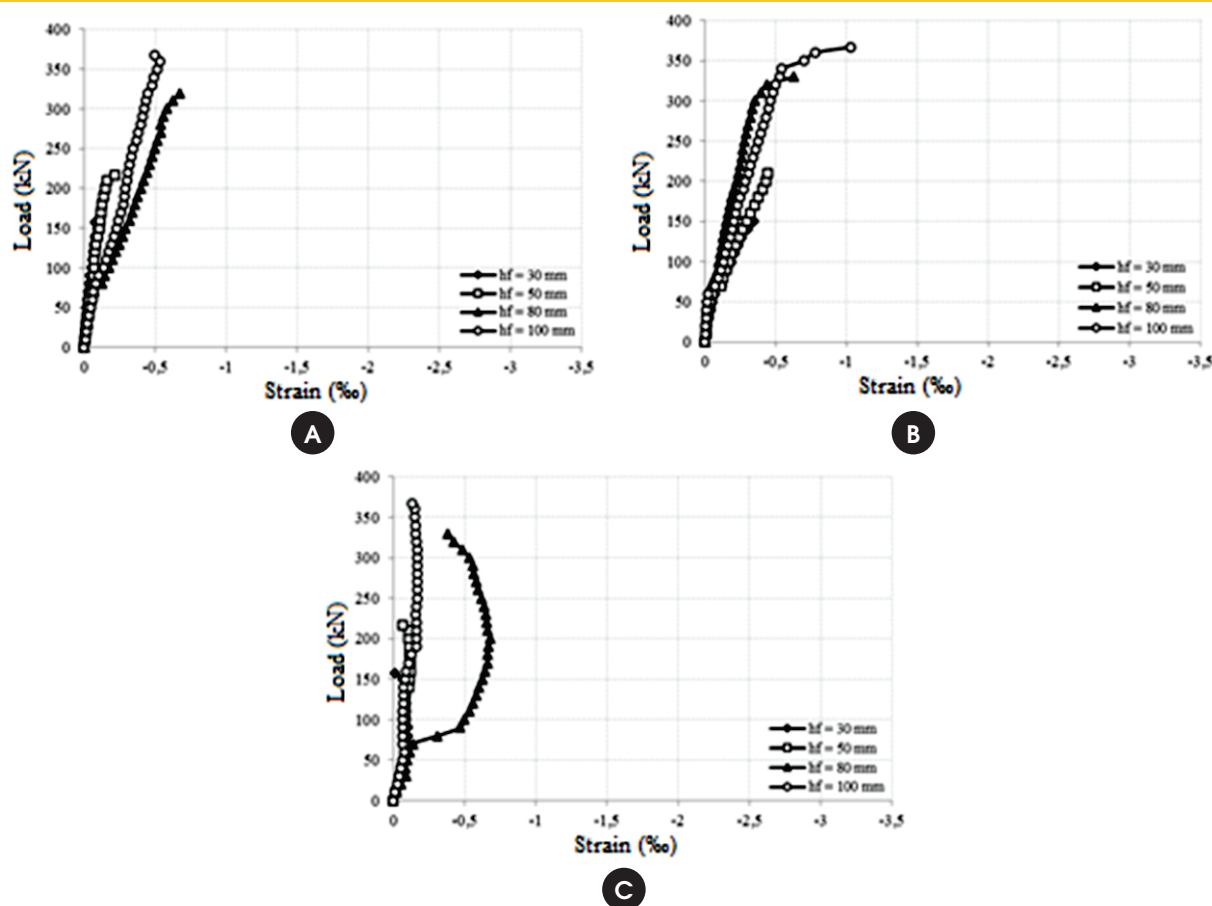
Figure 17 – L2000 slabs' concrete strains: (a) flexure of external rib; (b) flexure of midrib; (c) distribution of the table

The graphs of strains in concrete are shown in Figures 16 and 17. Table 3 shows the maximum strains of the concrete of the tested slabs and the respective sensors that recorded them. Unlike what occurred with the reinforcement's strains, the slabs did not show an increase in the values of the concrete strains proportional to the increase of thickness of the concrete table, or at least it was not clear this relationship, but all strains were much lower than the limit 3.5 ‰ for bended elements. In both groups of slabs curves were very close only for the initial stages of loading, tending to distance from each other as they neared the collapse.
