**UNIVERSIDADE FEDERAL DO PARÁ
INSTITUTO DE GEOCIÊNCIAS
PROGRAMA DE PÓS-GRADUAÇÃO EM GEOLOGIA E GEOQUÍMICA**

TESE DE DOUTORADO Nº 108

**DOS MINERAIS AOS MATERIAIS DE ARQUITETURA E
PROCESSOS DE DEGRADAÇÃO: EDIFÍCIOS E
ORNAMENTOS METÁLICOS DOS SÉCULOS XIX E XX EM
BELÉM DO PARÁ**

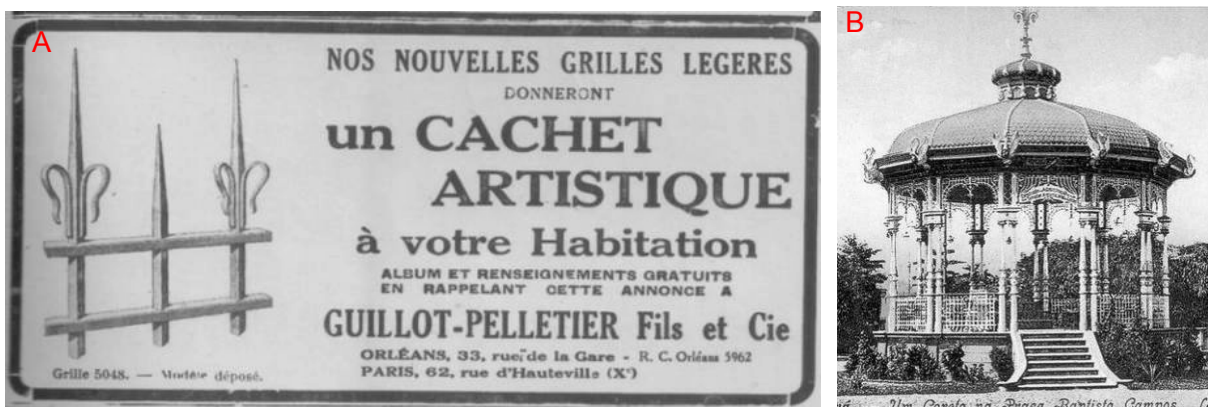
Figura 4 - A Anúncio de ornamentos metálicos produzidos pela *Guillot-Pelletier Fils et Cie*, em revista francesa (A); Coreto da praça Batista Campos (B). Fontes: Maumené, 1925; Acervo Dulcília Acatauassú Nunes.

Uma das fábricas que exportou de forma intensa para a capital paraense foi a companhia francesa *Guillot-Pelletier Fils & Cie*. Os anúncios dessa fábrica eram constantes nas revistas especializadas do século XIX (Figura 4A), e diversos edifícios da cidade apresentam características muito semelhantes ao desenho dos anúncios. Essa companhia inclusive importou pequenos edifícios para Belém, como o coreto de ferro da praça Batista Campos (Figura 4B).

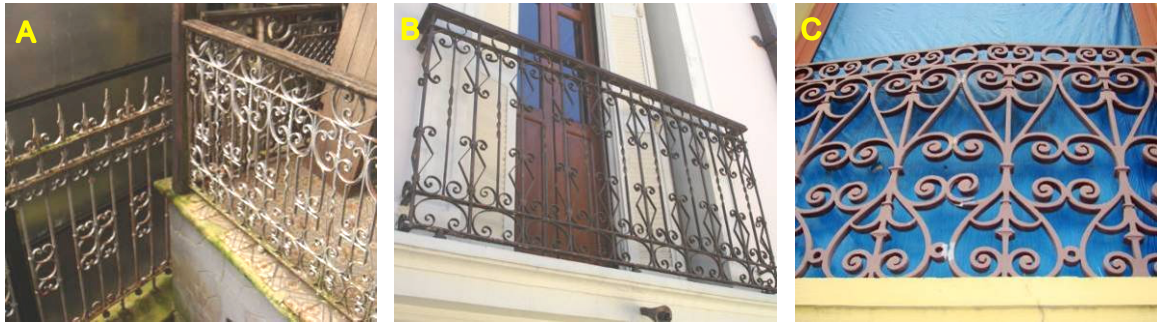
Figura 5 - Guarda-corpos das varandas do Palacete Faciola (A), Casa do Governador (B) e Palacete Pinho (C).

A semelhança de ornamentos antigos de vários edifícios paraenses com os desenhos de grades ornamentais anunciadas nas revistas estrangeiras, também representa a influência europeia na produção local. Vários modelos foram baseados naqueles vistos nas publicações, visando o requinte e a modernidade dos edifícios europeus, como, por exemplo, as grades do Palacete Pinho, do Palacete Faciola e da Casa do Governador (Figura 5).

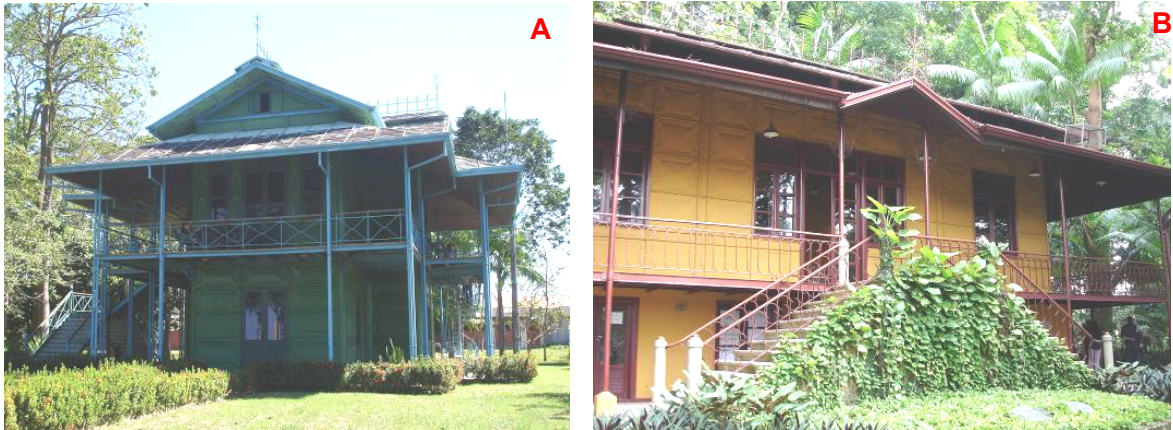
Figura 8 - Chalés de ferro da UFPA (A) e do Bosque Rodrigues Alves (B).

Os chalés de ferro em Belém são residências unifamiliares de proveniência belga, da fábrica *Forges d’Aiseau*, e construídos segundo o sistema Danly, criado por Joseph Danly. São os únicos exemplares residenciais no Brasil (Silva, 1987) construídos inteiramente em ferro, e recebem a denominação correspondente à sua localização. Eles são: o chalé da Universidade Federal do Pará (UFPA) (Figura 8A), do Bosque Rodrigues Alves (Figura 8B), e o antigo chalé da Imprensa Oficial do Estado do Pará (IOEPA) (Figura 9).

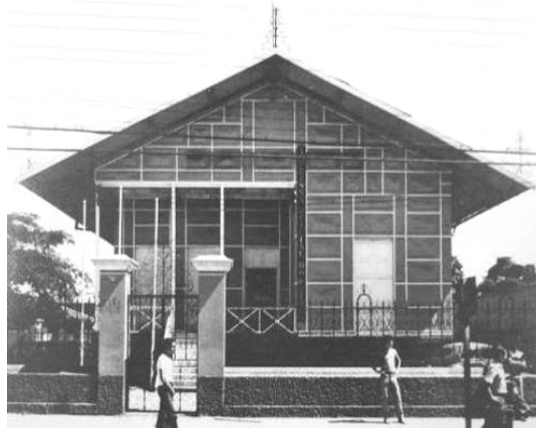
Figura 9 - Antigo chalé de ferro da IOEPA, em 1978. Fonte: Pontes et al, 1978

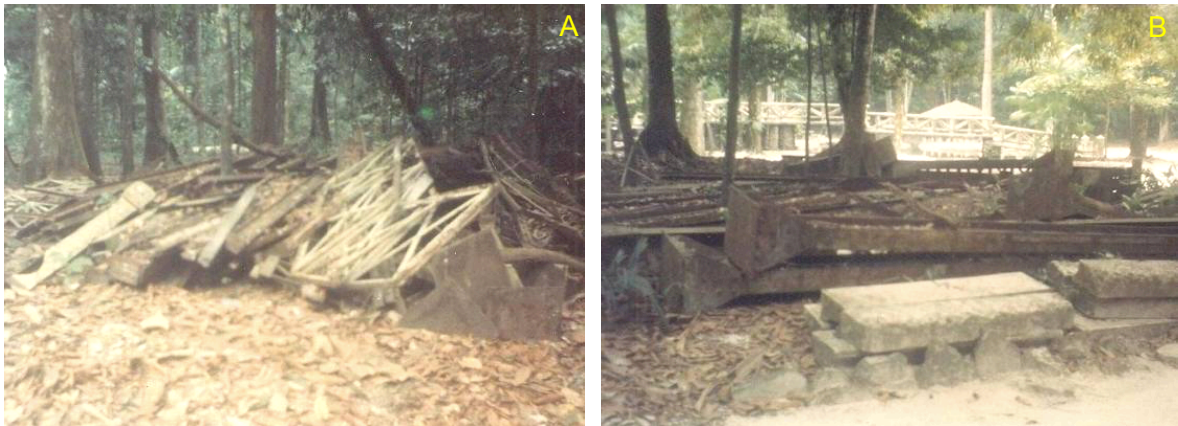
Figura 10 - (A) e (B) Peças do antigo chalé de ferro da IOEPA depositado no Bosque Rodrigues Alves no fim da década de oitenta do século XX. Fonte: Acervo Ronaldo Nonato Marques de Carvalho

Inicialmente, as peças do antigo chalé de ferro da IOEPA foram armazenadas no Bosque Rodrigues Alves em condições extremamente inadequadas (Figura 10):

“Quem vê as peças enferrujadas, cobertas por folhas, expostas ao sol e à chuva, entre as árvores do Bosque Rodrigues Alves, não diz que se trata de um dos três remanescentes chalés de ferro belgas que Belém possui como herança da fase áurea da borracha ”(O Liberal, 198-?)

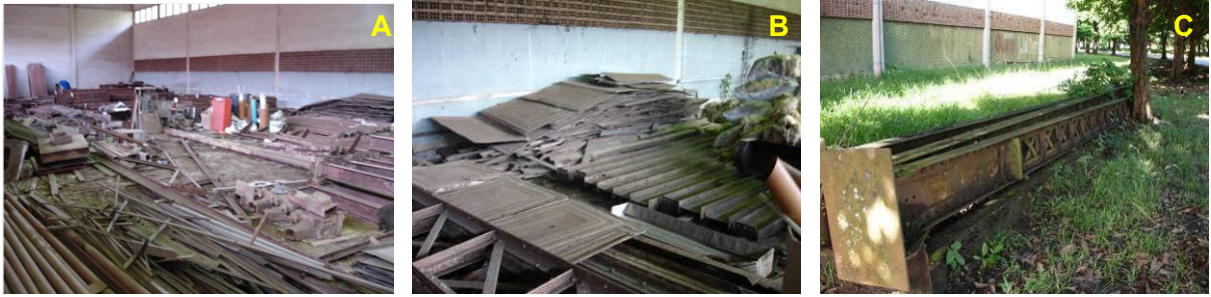
Figura 11- Peças do antigo chalé de ferro da IOEPA armazenadas no galpão de Engenharia Hidráulica (A e B); peças depositadas no exterior do galpão (C).

O armazenamento dos componentes arquitetônicos do edifício no galpão era inadequado. O espaço não era pavimentado e parte das peças ficou em contato direto com o solo, umidade e sujeira. A cobertura e as paredes do edifício que armazenava as peças, possuíam falhas por onde a água da chuva penetrava, aumentando o processo de corrosão dos elementos metálicos do chalé. Algumas peças foram deixadas no exterior do galpão, sem

proteção, o que intensificou ainda mais os processos intempéricos, e conseqüentemente o risco de não serem mais passíveis de utilização (Figura 11).

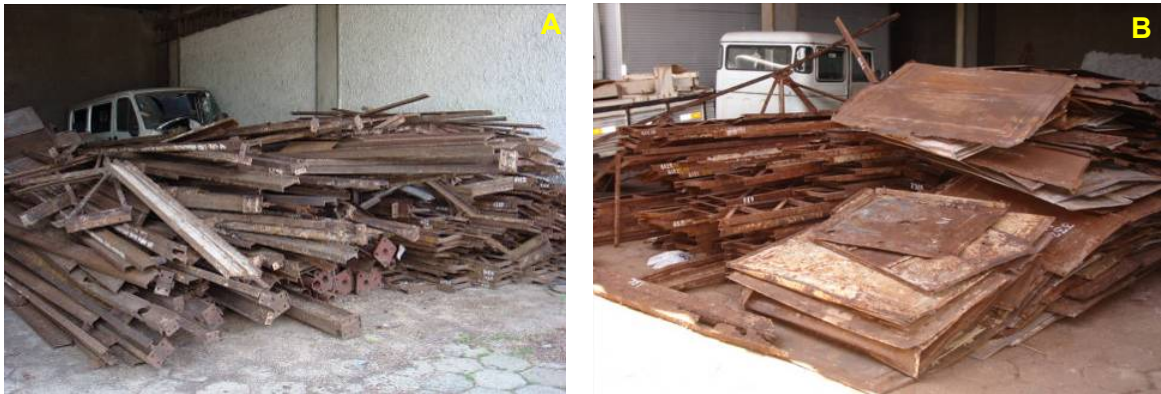
Figura 12 - Peças do antigo chalé de ferro da IOEPA armazenadas no setor de transportes da UFPA após o remanejamento.

Por motivo de reforma, em setembro de 2008, as peças do chalé começaram a ser remanejadas para o Setor de Transportes, também na UFPA. Ainda assim, o armazenamento era inadequado, já que boa parte das peças ainda estava em contato com a chuva (Figura 12).

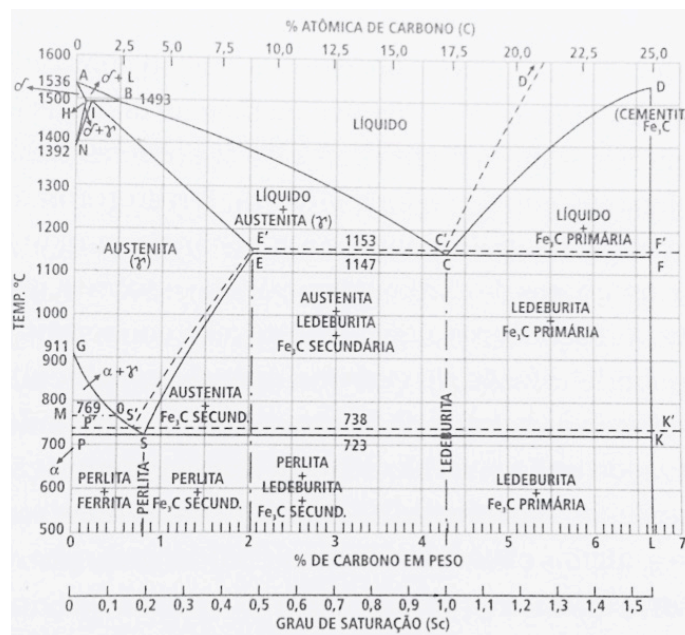
Figura 13: Diagrama de equilíbrio ferro-carbono. Fonte: GUESSER, 2009

As baixas temperaturas (até 912° C) o ferro tem a estrutura CCC. Acima desta temperatura, a estrutura CFC torna-se mais estável. Acima de 1394°C, a estrutura CCC volta a ser estável até o ponto de fusão do ferro (1535°C). Assim, as diferentes fases do ferro são estáveis em diferentes faixas de temperatura e de pressão (Figura 13) (COLPAERT, 2008).

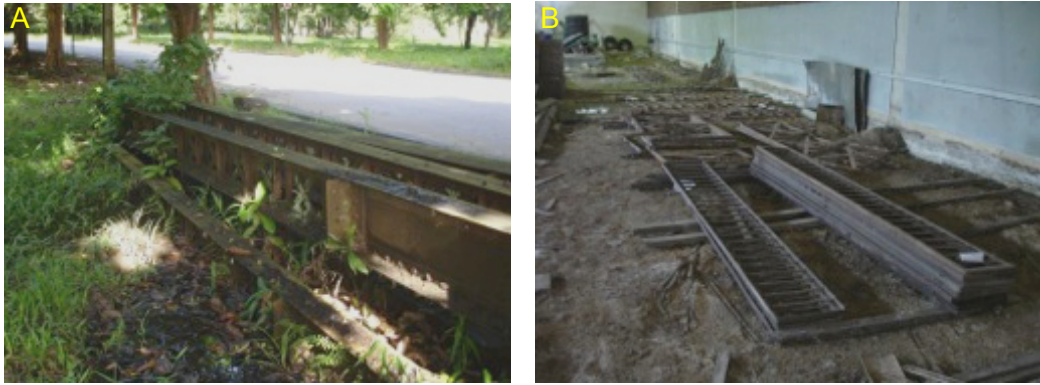
Figura 16 - Peças do antigo chalé de ferro da IOEPA expostas à constante precipitações (A), e expostas à ambiente de elevada umidade (B)

A magnitude da corrosão do metal na atmosfera depende essencialmente, do tempo de permanência da película de água na sua superfície, e esta depende da alta umidade ou ocorrência de precipitações (Figura 16).

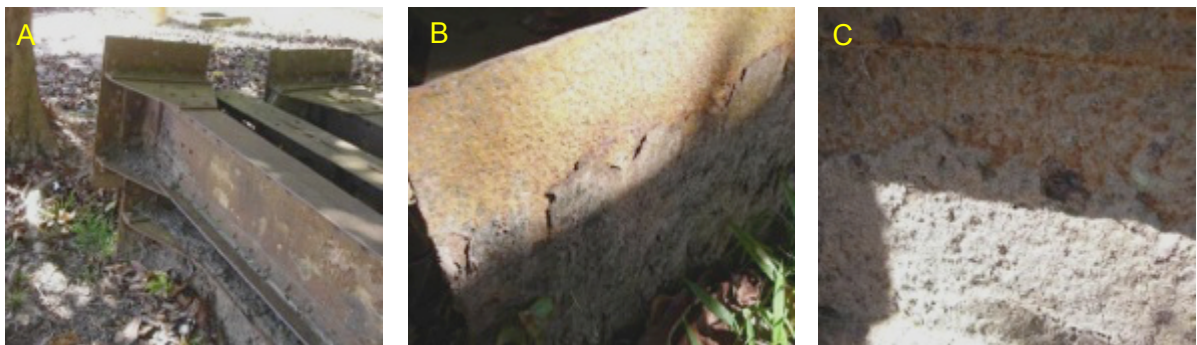
Figura 17 - Peças do antigo chalé de ferro da IOEPA em contato direto com o solo (A, B e C).

Alguns componentes metálicos podem estar enterrados no solo, como por exemplo, tubagens e estacas (Figura 17). Devido à grande variedade de solos existentes e à heterogeneidade, o perfil de corrosividade também é muito variado, em função da capacidade de retenção de água, presença de substâncias dissolvidas na água, variações nas concentrações dos constituintes solúveis, dentre outros fatores (Ramanathan, 2007). De modo geral, os solos argilosos e úmidos são os mais corrosivos devido à presença significativa de matéria orgânica e permeabilidade à água (Fontinha & Salta, 2007).

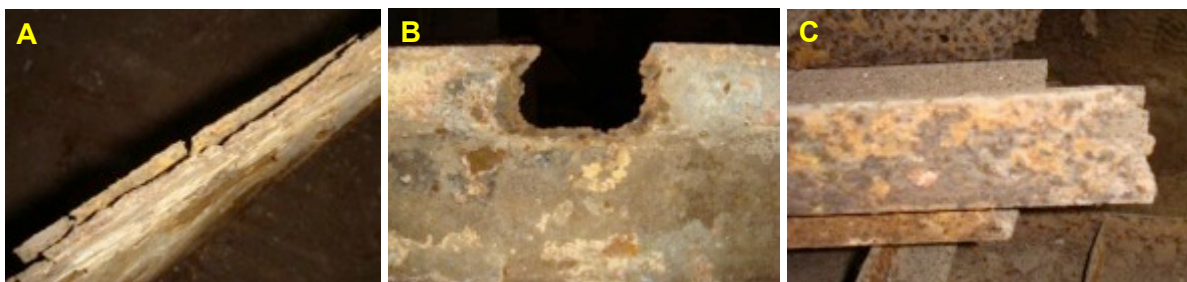
Figura 19 - Peças de vedação do antigo chalé de ferro da IOEPA com diminuição de espessura (A); perda de partes (B); e fratura (C).

- Perfuração;
- Diminuição de espessura (Figura 19A);
- Perda de elementos ou de partes do componente metálico (Figura 19B);
- Fissuras/ Fraturas (Figura 19C):

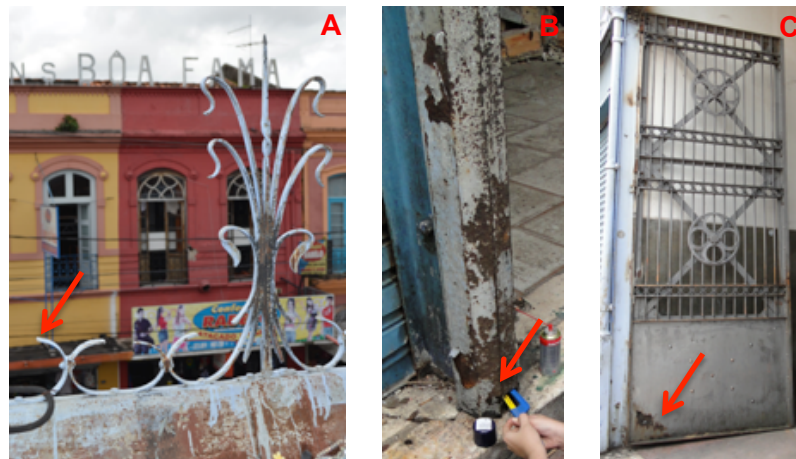
Figura 24 - Locais de retirada das amostras VP.OG1 (A), VP.C1 (B), e VP.P1 (C), pertencentes à amostragem de ligas metálicas do grupo de ornamentos.

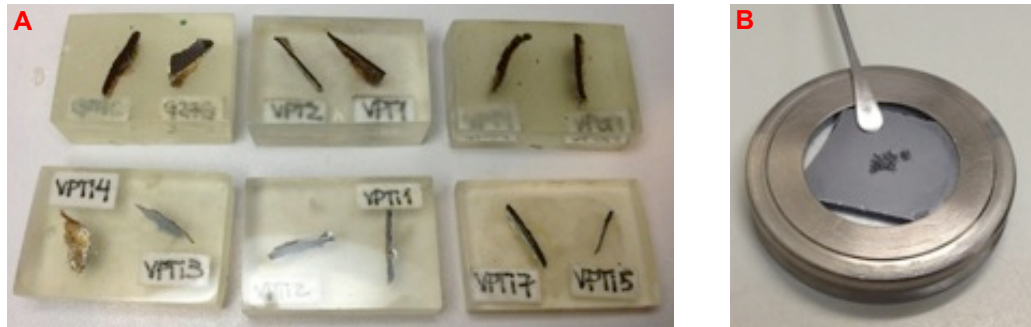
Figura 28 - Amostras preparadas para o MEV (A), embutidas em resina de poliéster; Amostra pulverizada para ensaio de DRX (B).

veludo lubrificado com alumina. O polimento final é com a aplicação de *spray* diamantado de 1μ (Figura 28A). Para o MEV, as amostras foram metalizadas em Au.

Para os ensaios em DRX, utilizou-se a micro-preparação devido a pequena quantidade de amostras. Estas são pulverizadas em grau de ágata, e o pó resultante é colocado diretamente no porta amostra (Figura 28B).

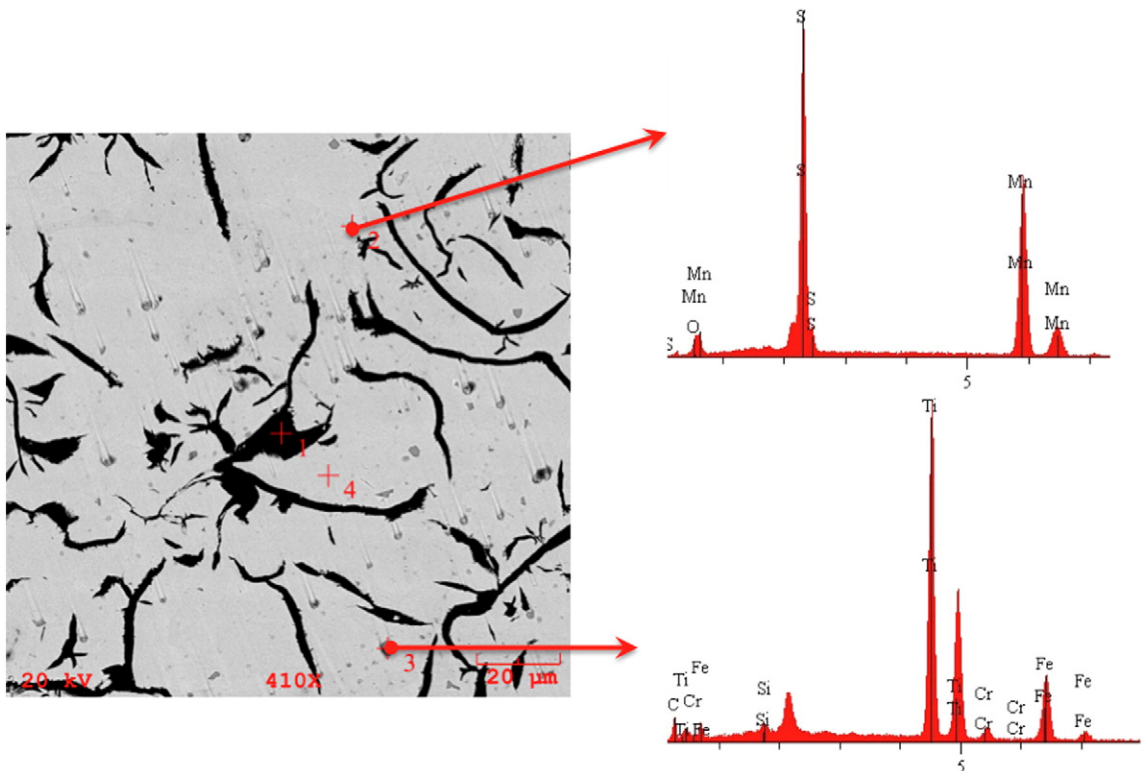
Fig. 6. SEM image of sample VP.C1 from Group 3 (ornament group), which present lamellae and circular shaped inclusions, and respective punctual chemical analysis.

The lamellae inclusions are presented in a sample from the water duct (VP.C1), from Group 3 (ornament group). The SEM image (Fig. 6) shows a very interesting pattern of irregular and curved lamellae, represented by dark lines in the ferrite matrix of the unaltered metal. Locally, circular inclusions can also be found, similar to those described in Group 1. These physical characteristics are very common in gray cast irons [5].

Chemical analysis by EDS showed that these lamellae are mainly constituted by C. However, it may also represent gaps or fissures in

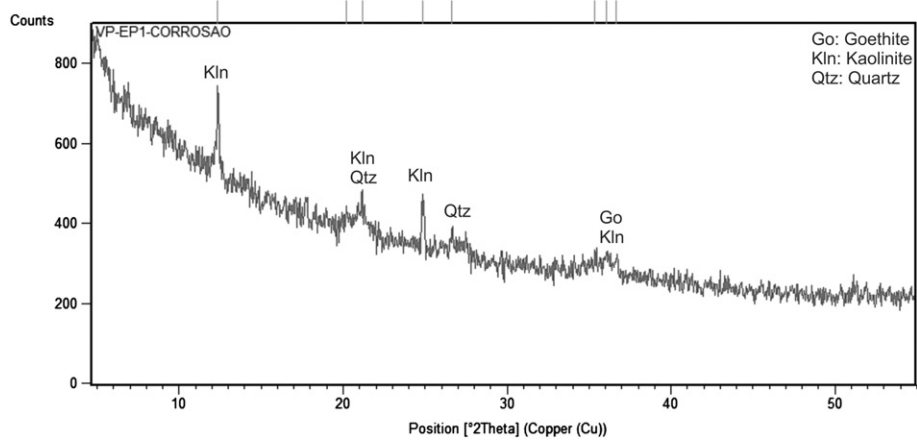
Fig. 10. Diffractogram of the sample VP-EP1, from the structure group of sampling, which presents goethite, kaolinite and quartz.

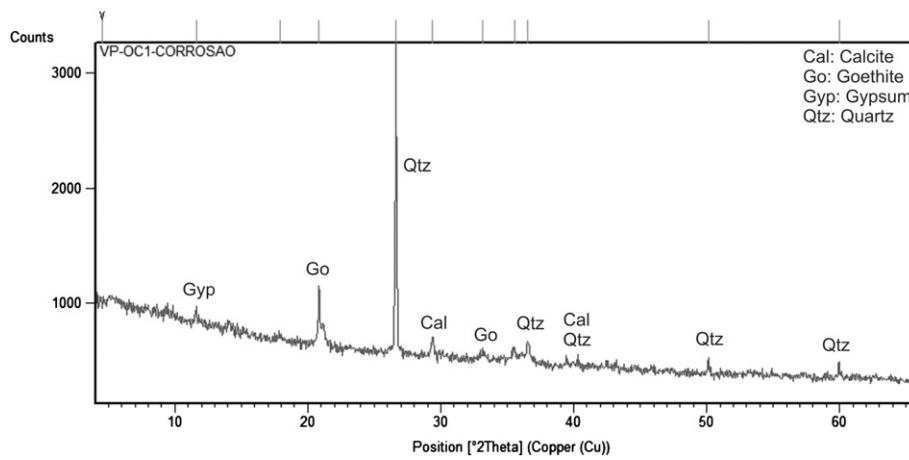
Fig. 11. Diffractogram of the sample VP-OC1 in ornament group, showing calcite, goethite, gypsum and quartz.

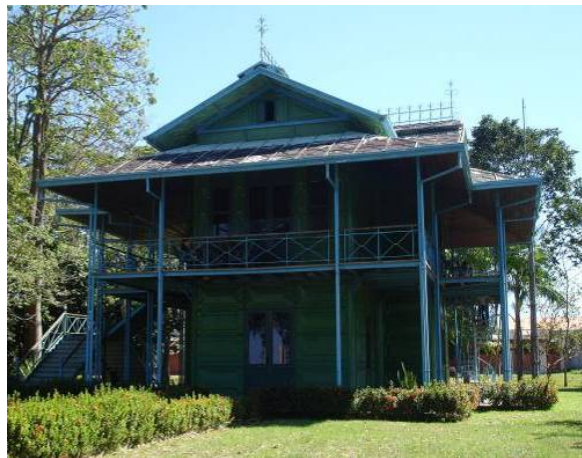
Figure 01- Iron *chalet* at UFPA

Two of the *chalets* were disassembled from its original site and reassembled at the Campus of the Federal University of *Pará* (UFPA) (Figure 01) and Rodrigues Alves Botanical Garden (Figure 02), both areas of great visitation. The buildings also received new color scheme and some minor interventions to adapt to their new urban site.

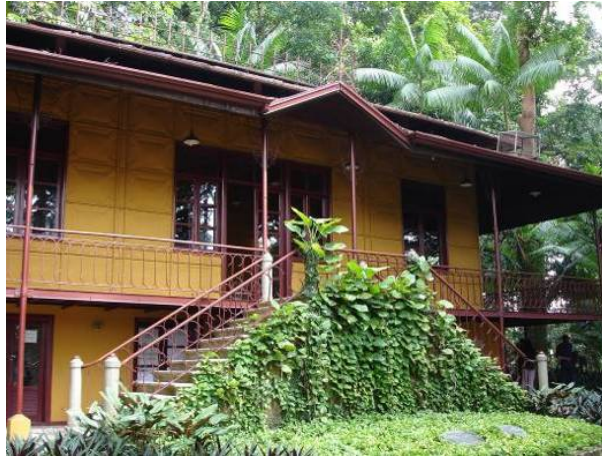
Figure 02 - Iron *chalet* at Rodrigues Alves Botanical Garden.

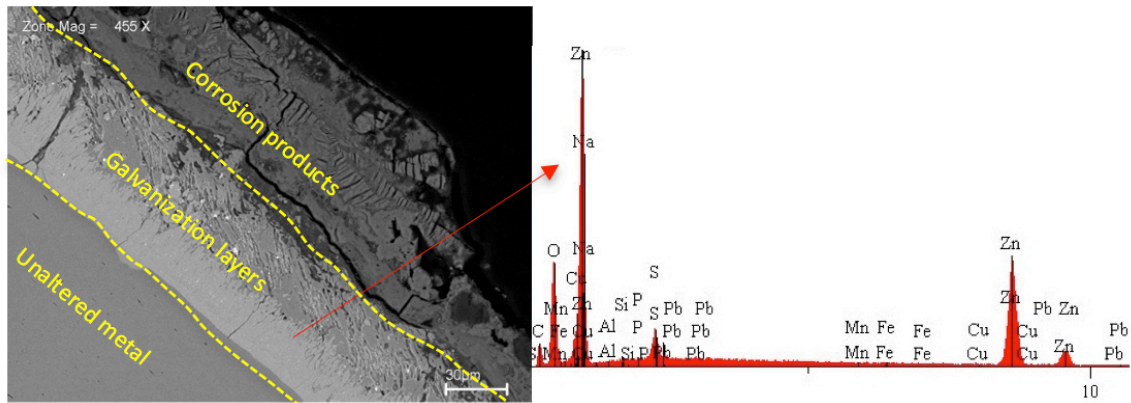
Figure 14 - Representative SEM image of samples (n° 3.18.1) associated with paint coat, presenting galvanization layer, presenting multilayered morphology.

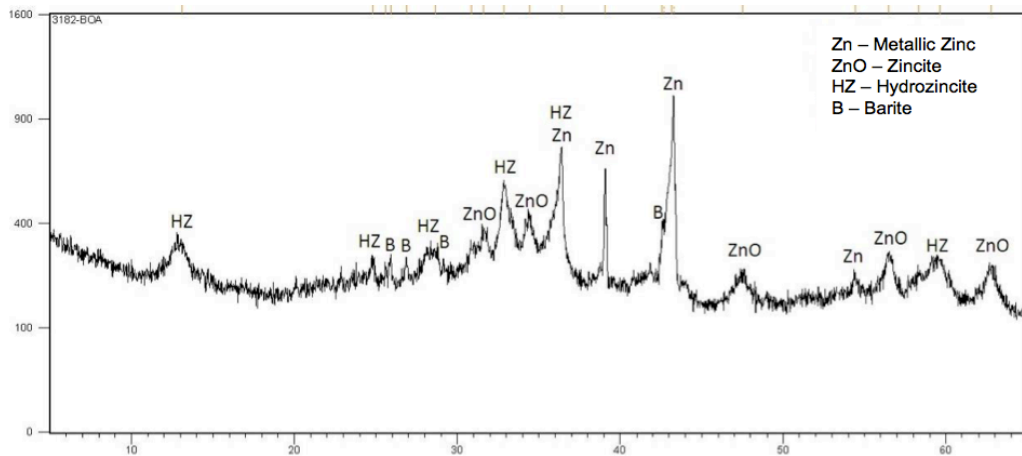
Figure 15 - Diffractogram sample of wall sheet 02 (n° 3.18.2), indicating classic corrosion process of the zinc in paint coats.

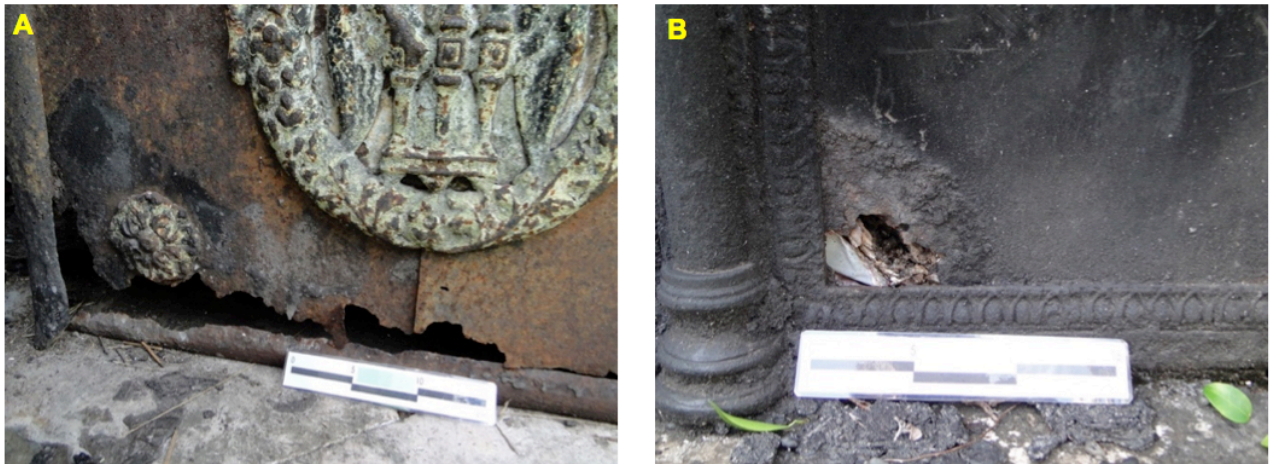
Figure 02 - Plane sheets from different mausoleums, which exhibit general corrosion, lacunae (A) and burned surfaces (B), due to mortuary rituals.

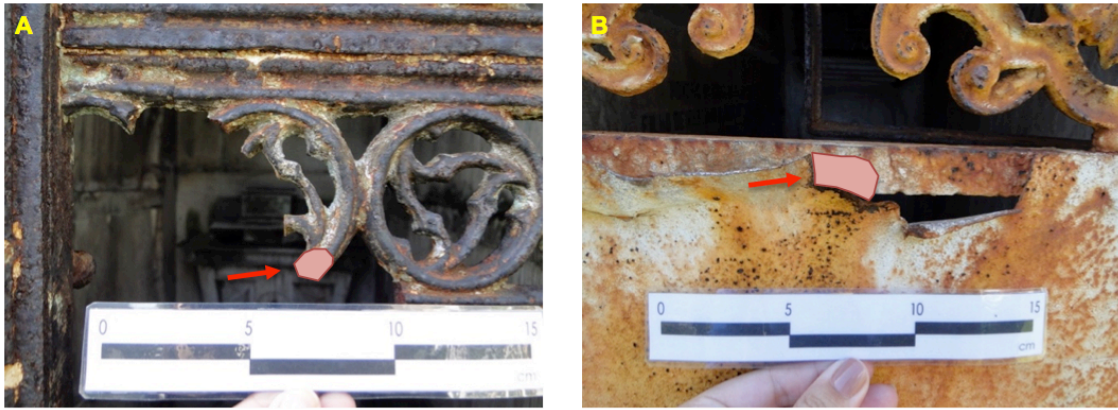
Figure 04 - Examples of areas where the samples were collected, presenting lacunae.

Sampling was allowed by IPHAN, and carefully carried out in small areas of the ornaments, specially the areas that present lacunae (Figure 04).

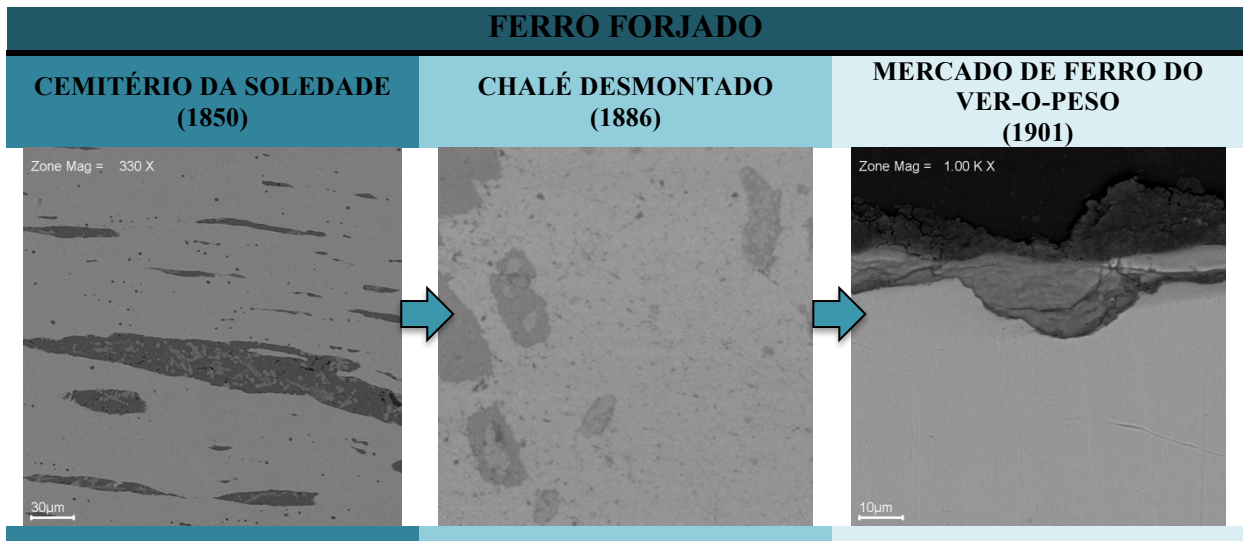
Figura 30 - Evolução das ligas de ferro forjado nos diferentes exemplares da pesquisa.
