Two-way ribbed flat slabs with shafts

Lajes lisas nervuradas bidirecionais com furos

The position of pipes and hoses for several installations still deserves special attention from designers mainly when the failure mode can be modified due to changes in behavior. This work compares experimental results of six two-way reinforced concrete ribbed flat slabs with rectangular holes close to the column and without shear reinforcement with the estimates obtained from codes ACI 318 and NBR 6118 equations. All slabs were casted and tested in the Civil Engineering Laboratory of UFPA and had dimensions of 1.800 mm x 1.800 mm x 150 mm and were submitted to central loading applied through 120 mm side square steel plates simulating the columns. EPS was used as inert material and the ribs were spaced 250 mm with 130 mm height and 75 mm average wide. The results showed that the codes' shear equations estimates agree when the ribs are considered as beam and also for punching shear, but tend to be safer when the slabs present two shafts.

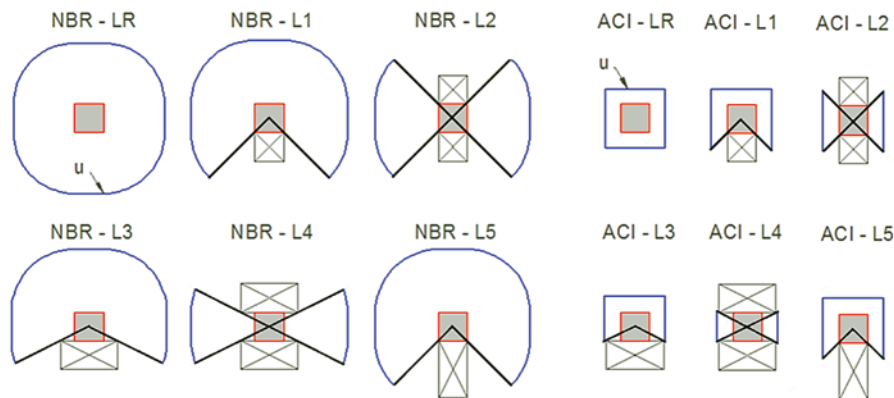
Six reinforced concrete ribbed flat slabs were tested in the laboratory of civil engineering of Federal University of Pará. The slabs were square with sides of 1,800 mm and were 150 mm thick. The main variables were the position and size of the holes. A slab without holes was tested as reference to all others, which had holes adjacent to the column. Figure 3 and Table 1 present the main characteristics of tested slabs. Figure 4 shows the position of the holes in the vicinity of the columns for all slabs and their control perimeter drawn according the recommendations presented by ACI and NBR 6118.

Figure 4 - Normative control perimeters for the tested slabs

In terms of the punching shear resistance, except for slab LR, all codes tended to underestimate the experimental results. This was more significant when slabs had two holes or one hole only, but largest than the column. For these cases, the length of the effective control perimeter is smallest if compared to the length of the perimeter of a slab without holes. Reductions reached 72% (L4) for ACI 318 and 50% (L2) in NBR 6118 in the case of slabs with two holes. In the case of slabs with one hole only, reductions were up to 21% for ACI 318 and 12% for NBR 6118.

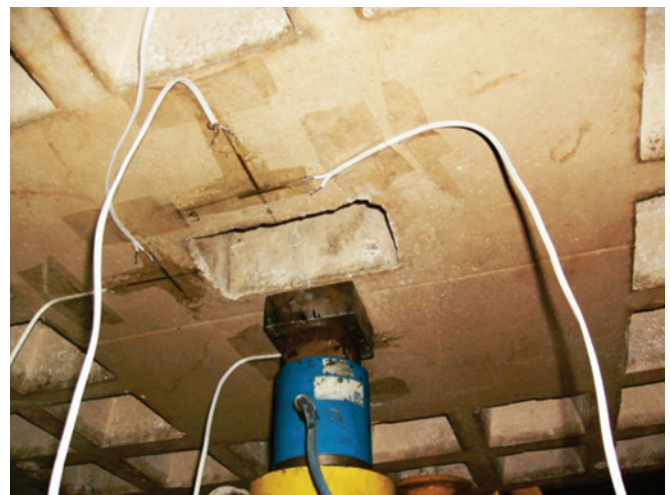
The number and spacing of flexural rebars was the same for all slabs. The minor differences in the flexural reinforcement ratio (ρ) of the slabs, which varied between 0.42% and 0.46% as shown in Table 1, refers to changes in the effective depth of the slabs (d) after assembling the reinforcement. The values measured of (d) before casting the slabs ranged from 128 mm to 134 mm. EPS was used as inert material to replace the concrete volume under the cover and between the ribs of the slabs. The slabs were submitted to concentric loading applied through a square steel plate with sides of 120 mm and with thickness of 50 mm. The steel plates were used to simulate the columns and the loading was applied upwards by a hydraulic jack with a capacity of 1,000 kN. Reaction beams were placed over strips of chartered rub-

bers and the distance between the axes of the reaction rods was 1600 mm. Figure 5 shows the test system.

Figure 5 - Test system

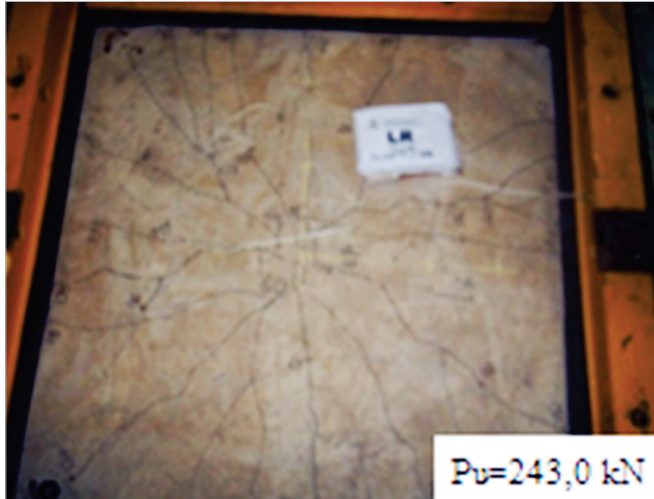
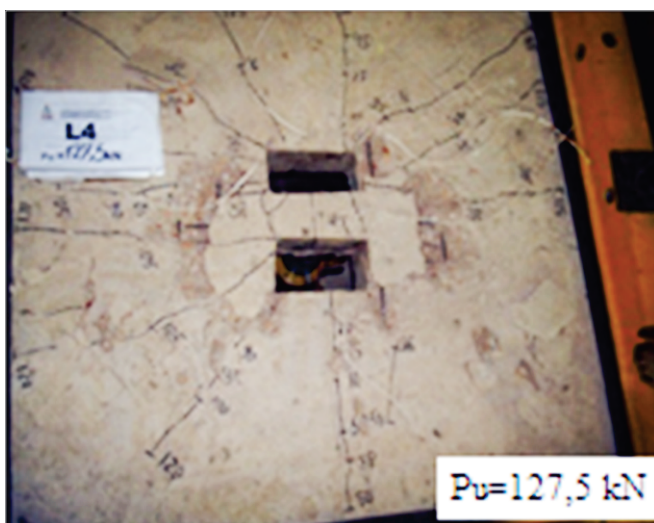
The cracking pattern of the tested slabs is shown in Figure 9. For

all slabs, cracking initiated and propagated radially toward the hole with a slight reduction in the number of cracks in the region on the back of the holes. In the case of slabs with holes, it was also observed that most of the cracks initiated in the corners of the holes, evidencing the stress concentration in this area, confirming results from finite elements computational analysis.

Figure 9 - Cracking pattern of tested slabs

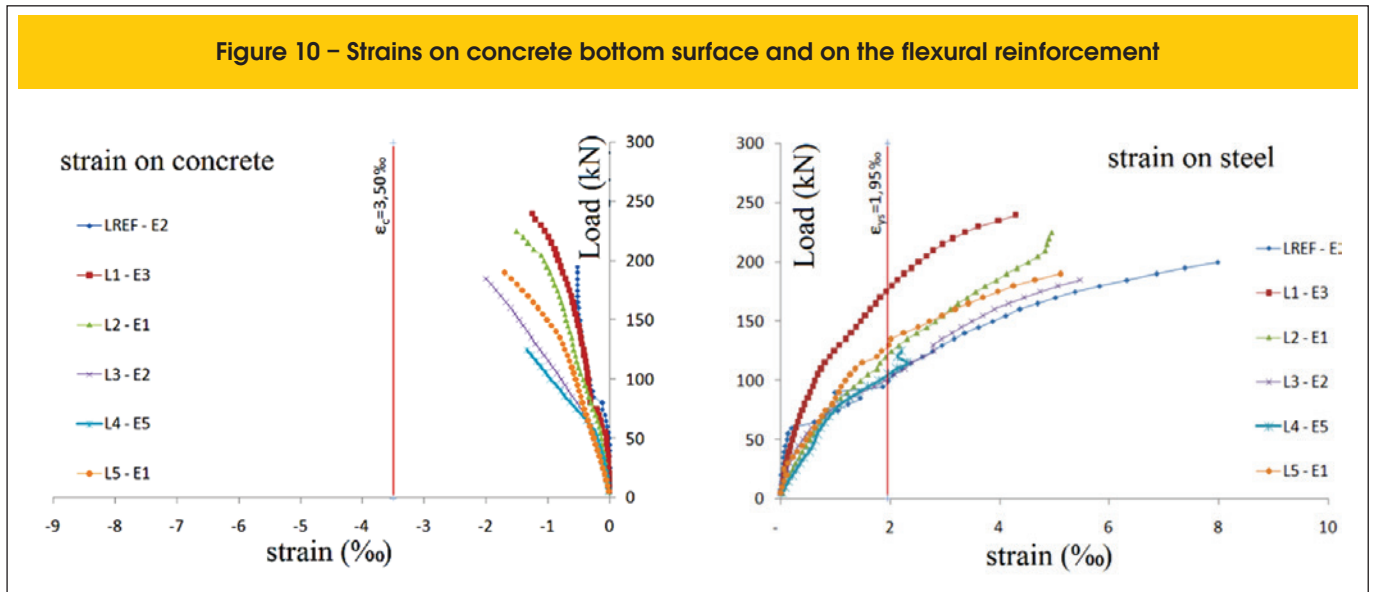
Strains on the flexural reinforcement measured on tests indicate a ductile response of all tested slabs, with all installed gauges recording strain values above the yield strain (1.95‰). Figure 10 shows load-strain curves for the flexural rebars in all tests. The largest

flexural strains were observed in slab LR, in which values recorded reached 8.5%. In the other slabs, flexural tensile strains were between 2.6% and 5.2%, quite above the yield strain. Slab L1, nevertheless, showed a peculiar behavior, presenting the smaller strain increment for loads above 75 kN. It should be emphasized, however, that this behavior does not characterize a flexural failure of this slab, once this response may be restricted to the monitored region, and especially because the slab continued absorbing load increment until it failed by punching shear. Strains in the concrete bottom surface in the vicinities of the column are also shown in Figure 10. In general, the maximum values were around 0.5‰ to 2.0‰, far from the limit of 3.5‰.

Figure 10 – Strains on concrete bottom surface and on the flexural reinforcement
