# **Analysis of the Safety Monitoring of Earth Dams at the Belo Monte Hydroelectric Plant: Case Study of Dikes in the Filling and Operation Scenario**

MODESTO, R. R.<sup>1</sup>; ALENCAR JÚNIOR, J. A.<sup>2</sup>; LIMA NETO, A.<sup>3</sup>.

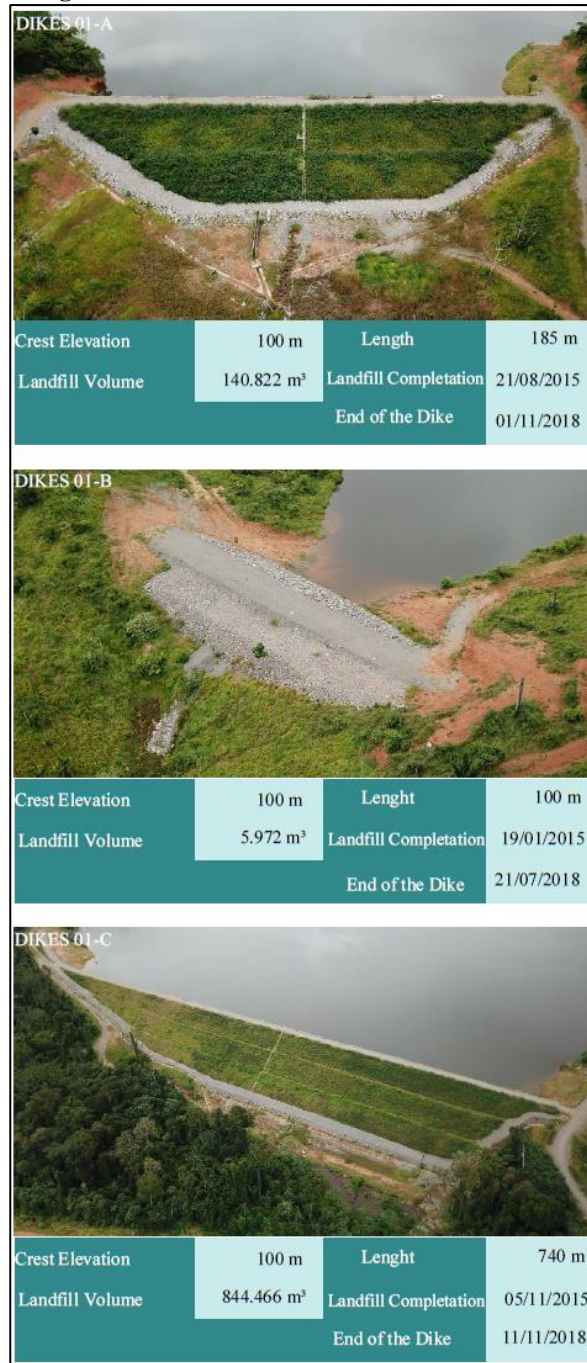
**Figure 7 – Constructive characteristics of dikes**

The intermediate reservoir is formed by 28 containment dikes and is located, in its entirety, in the municipality of Vitória do Xingu and is limited by the Vertente do Santo Antônio dams, Left Lateral Closure, Right Lateral Closure and Water Intake, as shown in Figure 5. Dikes 01-A, 01-B and 01-C are intended to allow the creation of the intermediate reservoir, closing natural drainage valleys and water leakage points located in topographic saddles and are located on the left side of the intermediate reservoir , located in the thalweg of the drainage area of the Santo Antônio stream. The distance between dikes 1A, 1B, 1C and the Xingu River varies from 8.8 km to 10.9 km, passing through the Transamazônica highway (Figure 6). Constructive characteristics such as crest elevation, volume of the landfill, length, period of completion of the landfill and completion of dikes 01-A, 01-B and 01-C are represented, respectively, in Figures 7a, 7b and 7c.
